O. Napoly, CEA-Saclay, Irfu/SACM

**CEA contributes to the
XFEL Cold Linac construction
through
String Assembly in Clean Room (WP9)
and Module Assembly (WP3)**

**Accelerator Module Assembly
assembly of 103 accelerator modules
with 1 per week throughput !
operated by an industrial contractor
on the **Saclay** site.**

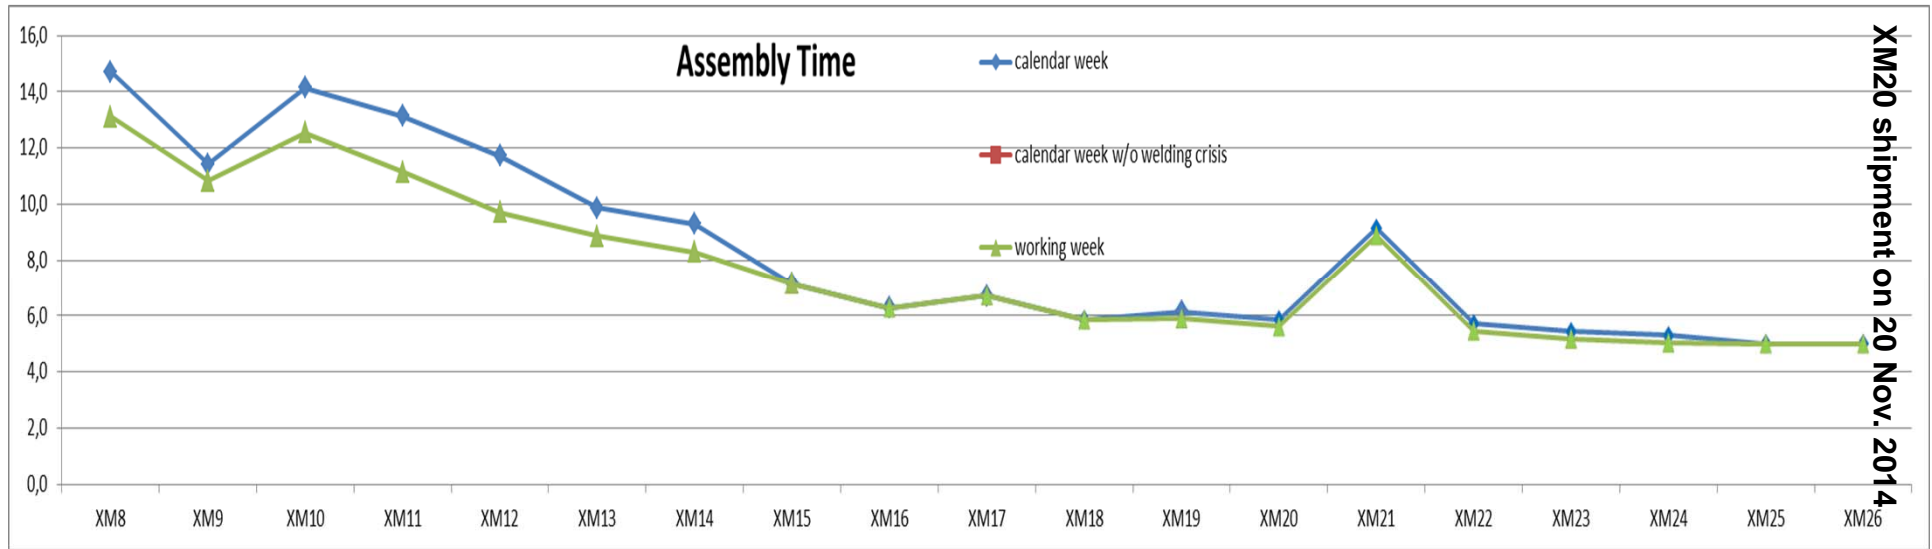
Status of Assembly: 20 cryomodules delivered to DESY

The nominal assembly time of 7 weeks has been reached with XM15.

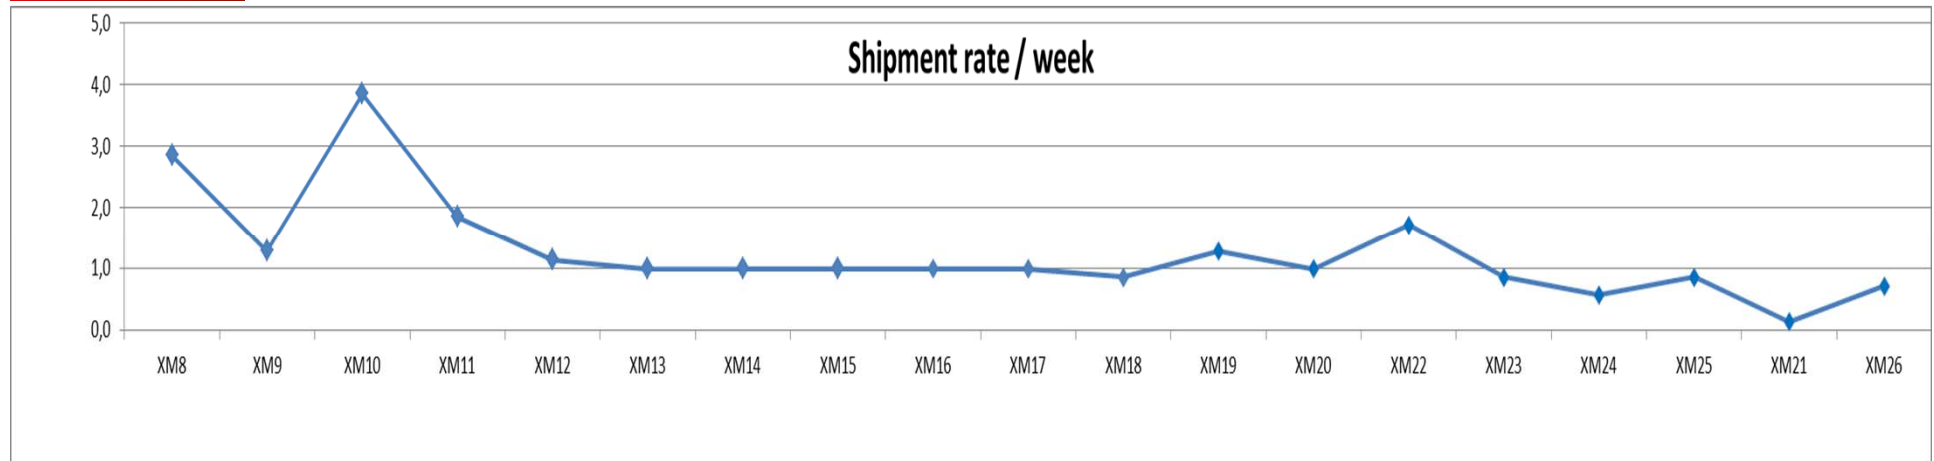
Status of Assembly: 20 cryomodules delivered to DESY

The nominal throughput of 1 module per week has been reached since XM12 (24/09/2104).

Assuming 1 CM/week from then on:

- XM24 shipped end of 2014
- XM71 shipped end of 2015
- XM82 shipped end of March 2016
- XM100 shipped 2nd August 2016 (w30)

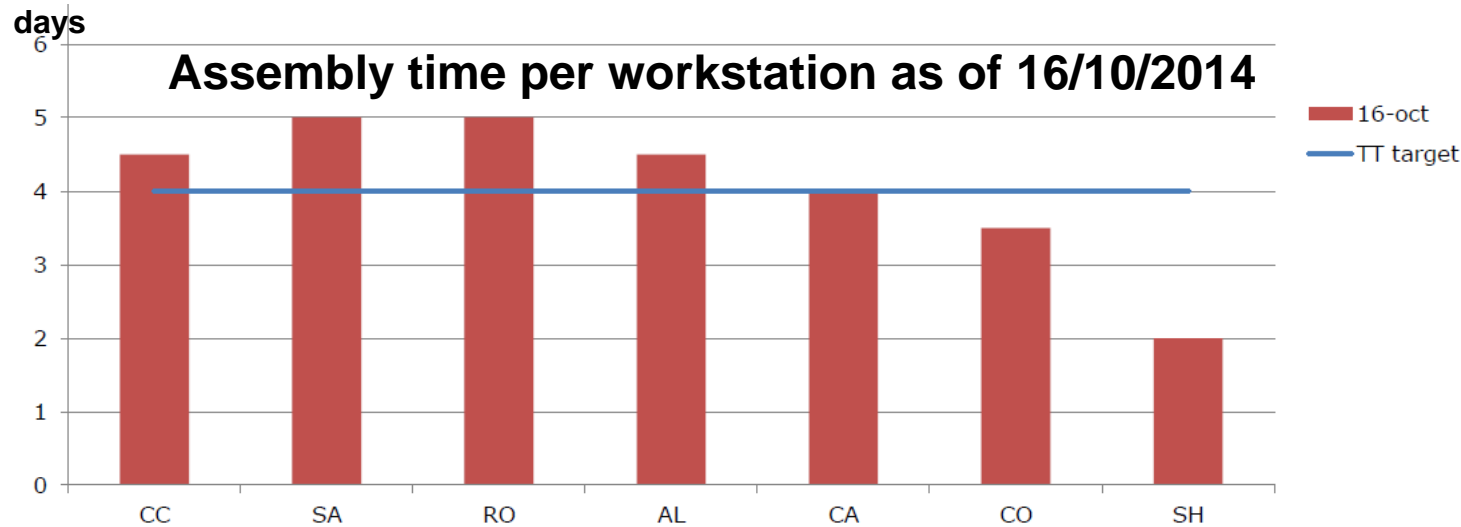
Status of Assembly: 4-day throughput in sight

Assuming 1.25 CM/week from end of November 2014 (throughput of 1 Module / 4 days):

- XM25 shipped end of 2014
- XM83 shipped end of 2015
- XM98 shipped end of March 2016
- XM100 shipped 12 April 2016

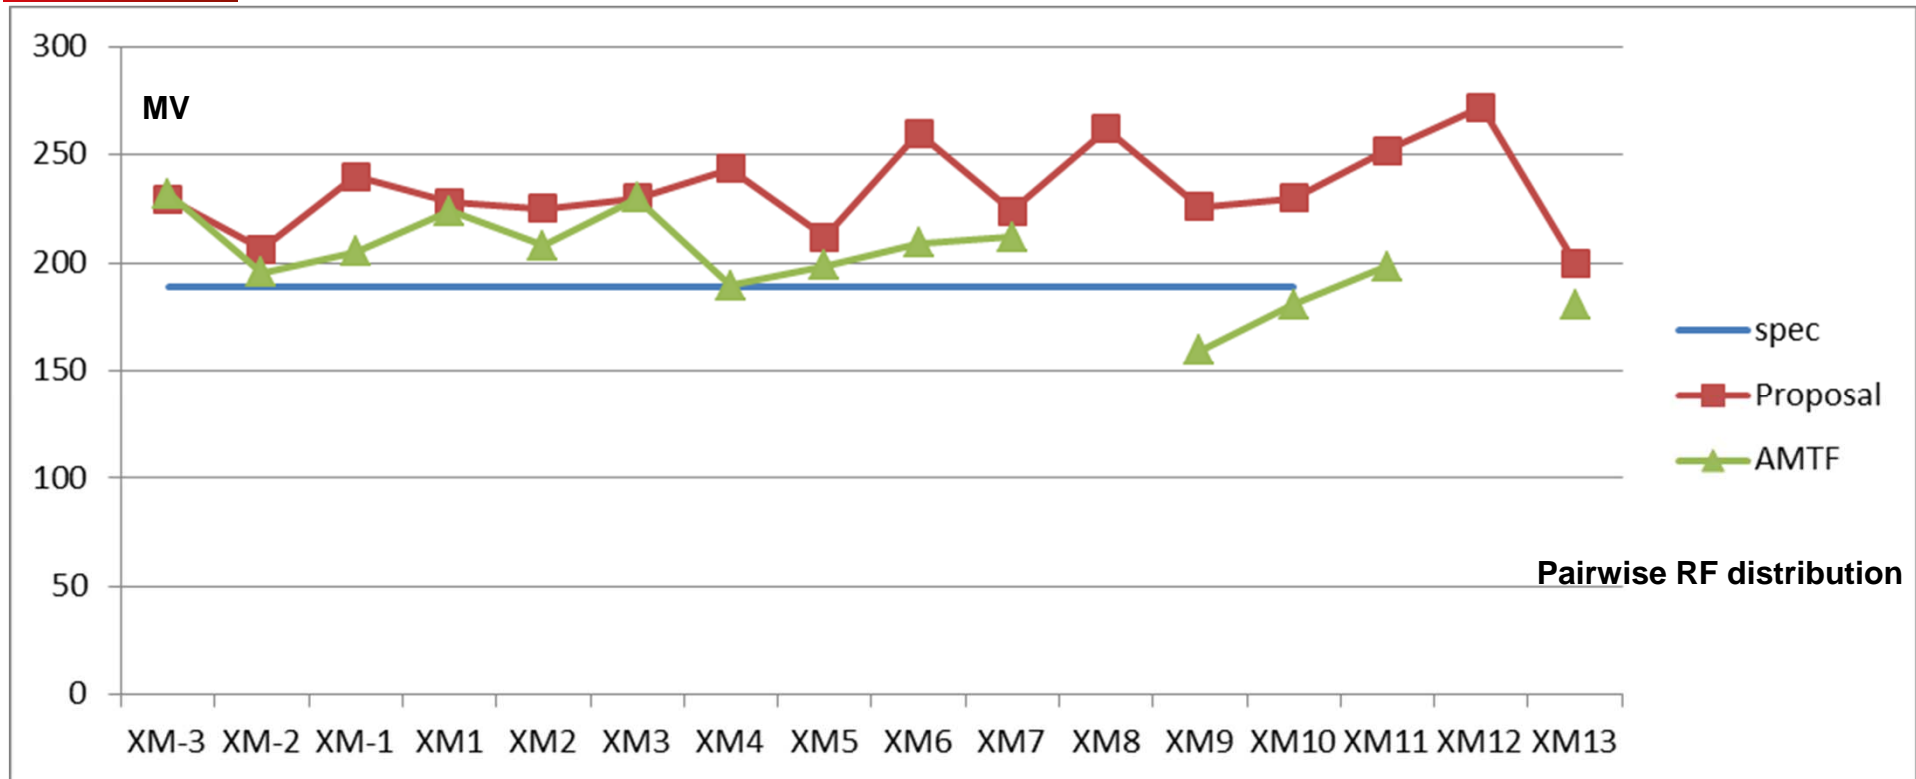
Status of Assembly: 14 cryomodules tested at AMTF

- Integrated over 14 modules: +7% above specs, -14% below VT 'reference' gradient
- Four modules lost about 50-60 MV: XM4, XM6, XM9, XM10 and XM11: main cause is early quench, but also large field emission.
- XM8 is parked after a leak detected on the 2K LHe circuit. Investigations will follow.

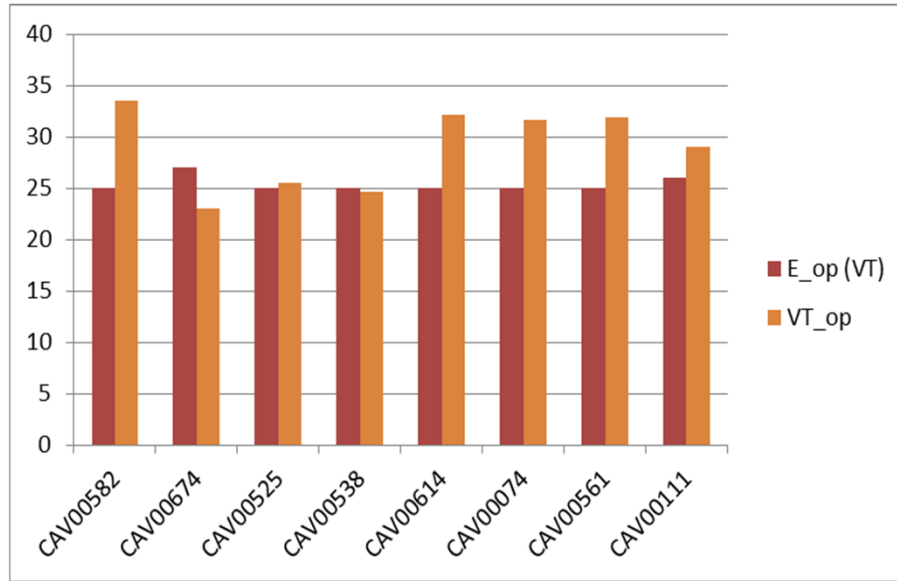
XM13 RF Test Results at AMTF

XM13 cavity selection communicated to CEA with 'E_op' gradients on **May 15, 2014**

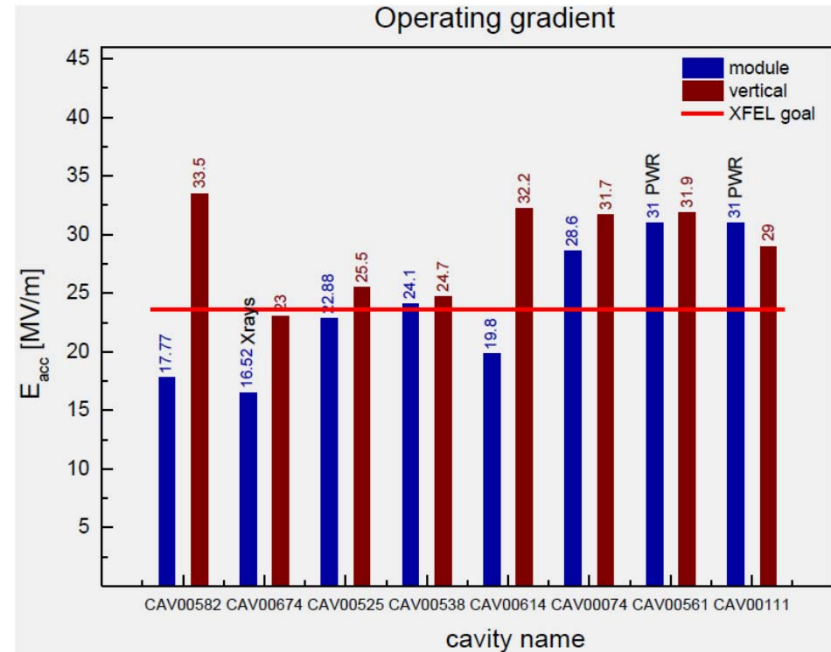
XM13 RF results at AMTF, with 'VT_op', communicated to CEA on **Nov 12, 2014**

There is indeed a degradation of cavity gradient, and many times, of the quench limits.

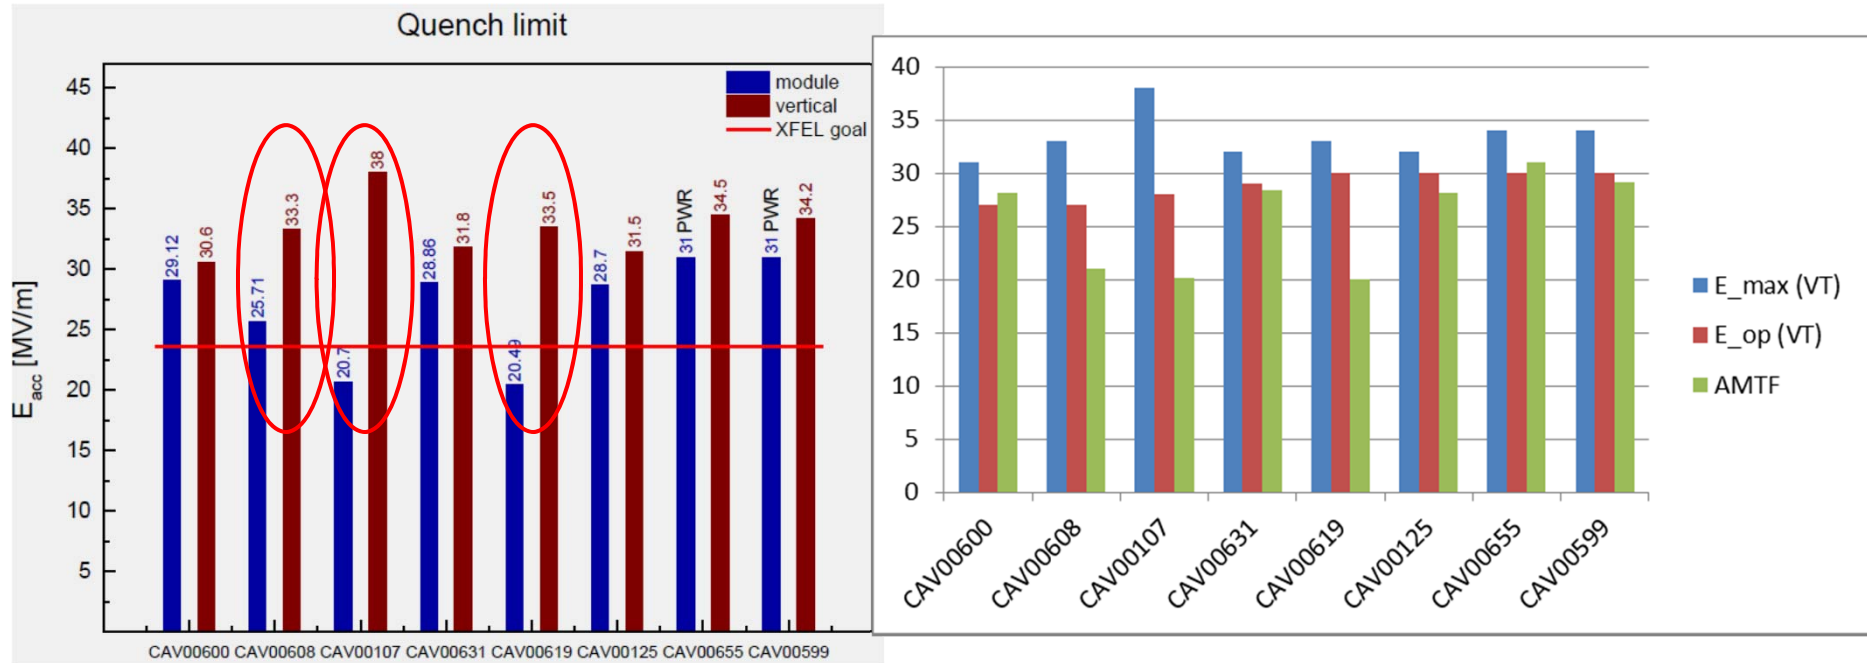
XM10 RF Test Results at AMTF

Cavities 2, 3 and 5 have very early quenches

- Vert. test average: 28,8 MV/m
- **Module test average: 22,6 MV/m by pairs**
- Module test average: 25,8 MV/m by single cavity power distribution
- XFEL specification: 23,6 MV/m

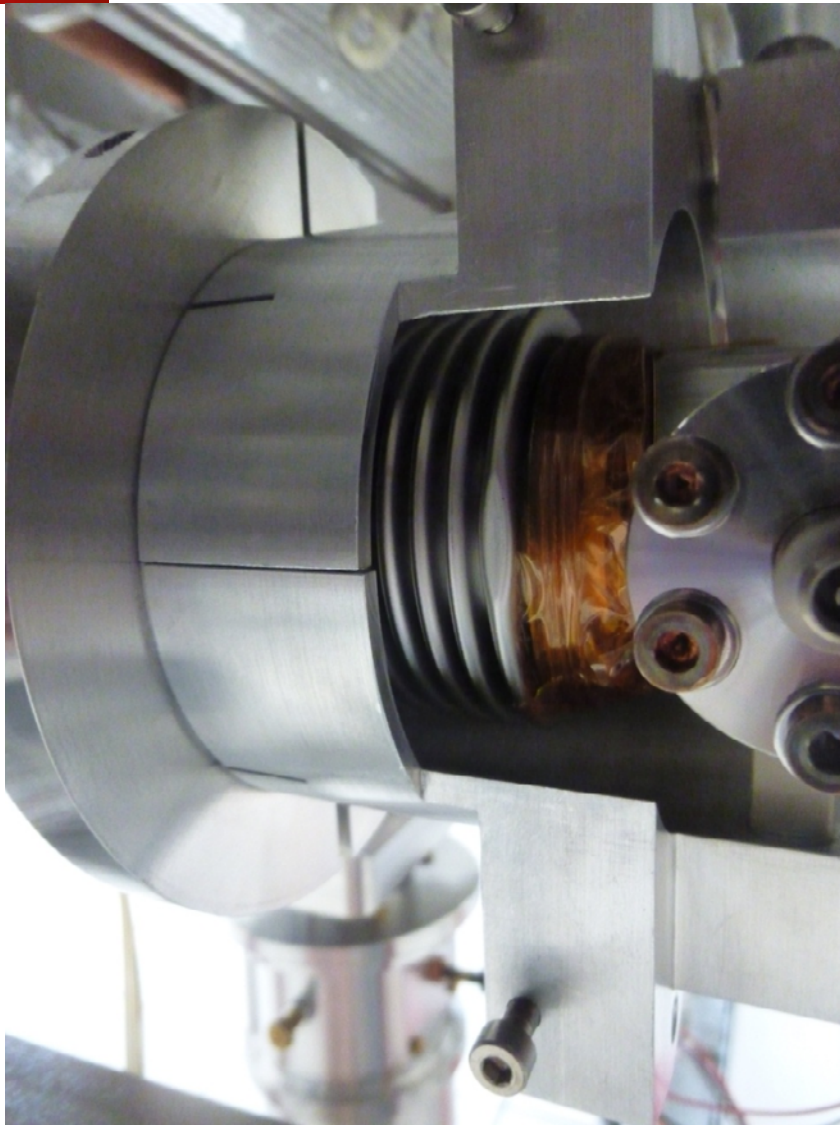
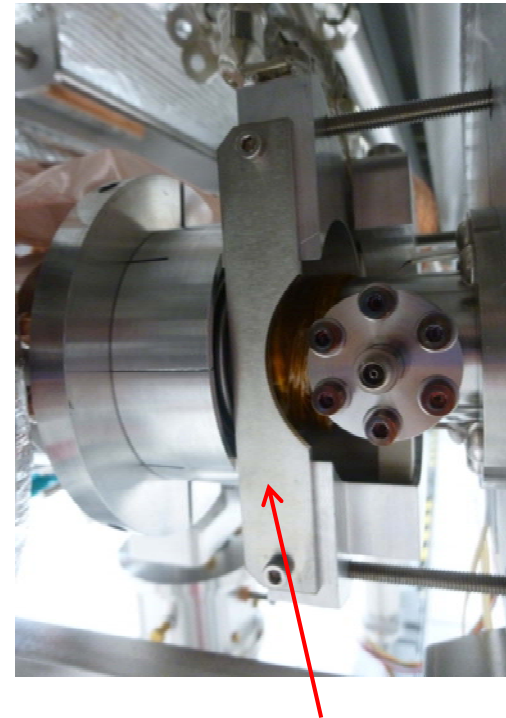
XM10 Incidents at Roll-out Assembly

Cavity n°2 : dent on the coupleur bellow

The dent might have been caused by the assembly of the part linking the two half 4K-interfaces.

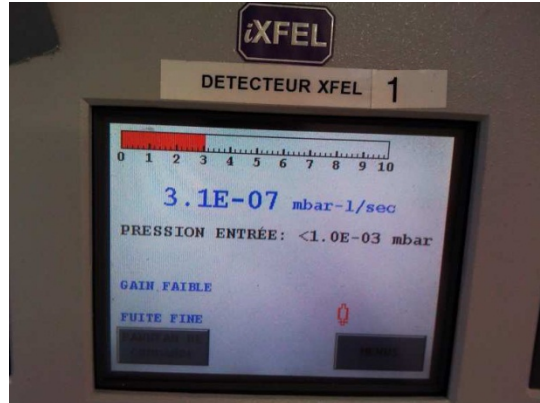
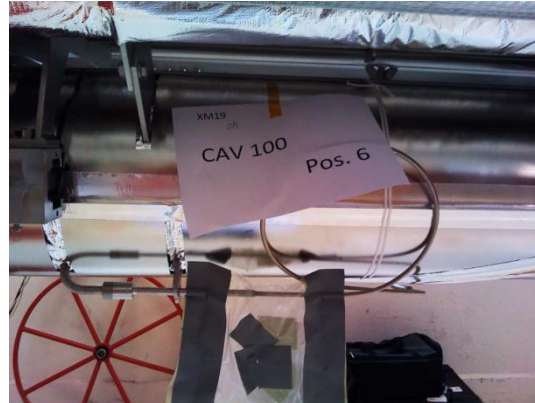
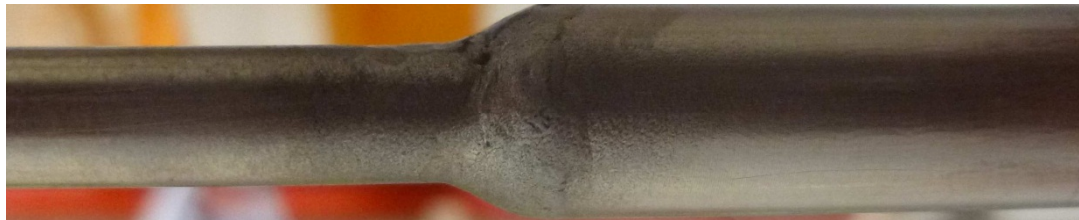
Leaks on LHe Circuit on XM19

Leak on the 2K service tube of XM19 cryogenic distribution system

This leak introduced a delay of 3 days for the repair and the inspection by DESY and TUV.

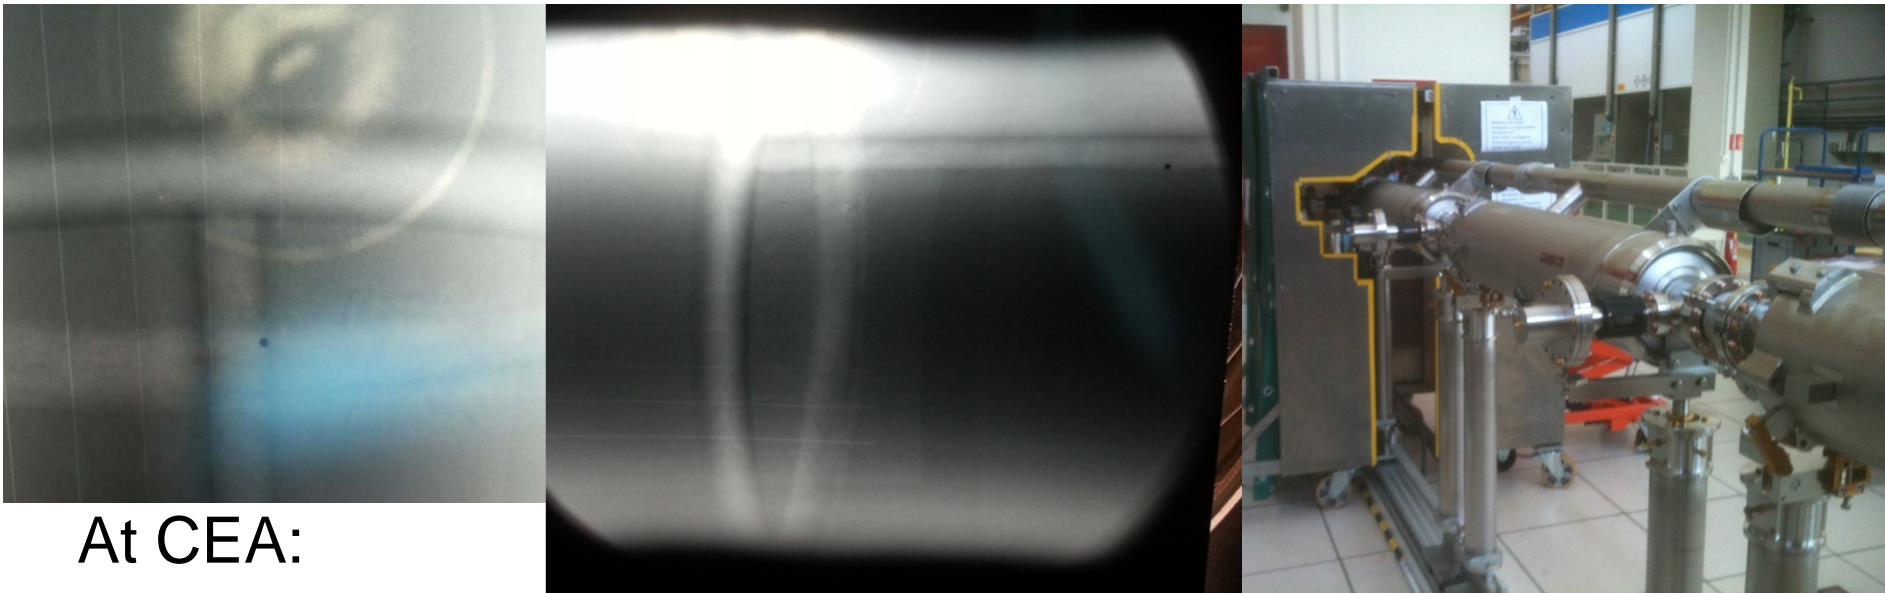
Orbital welds 16/76 of XM14 and XM15

Porosity problem remained from the longitudinal weld (16/76) of the 'cavity1 extension pipe' to cavity 1 upstream pipe.

- X-Ray radiography contract with SGS from XM15, including X-Ray of repairs within 24h, accepted by SGS.
- Lead protections in place allow for stand-alone radio campaigns since XM14

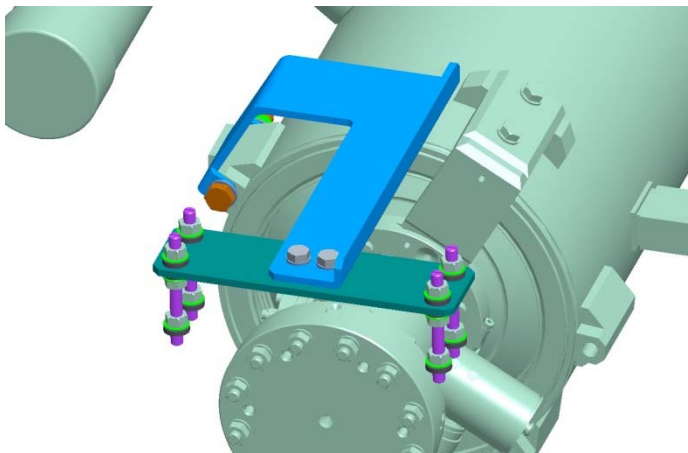
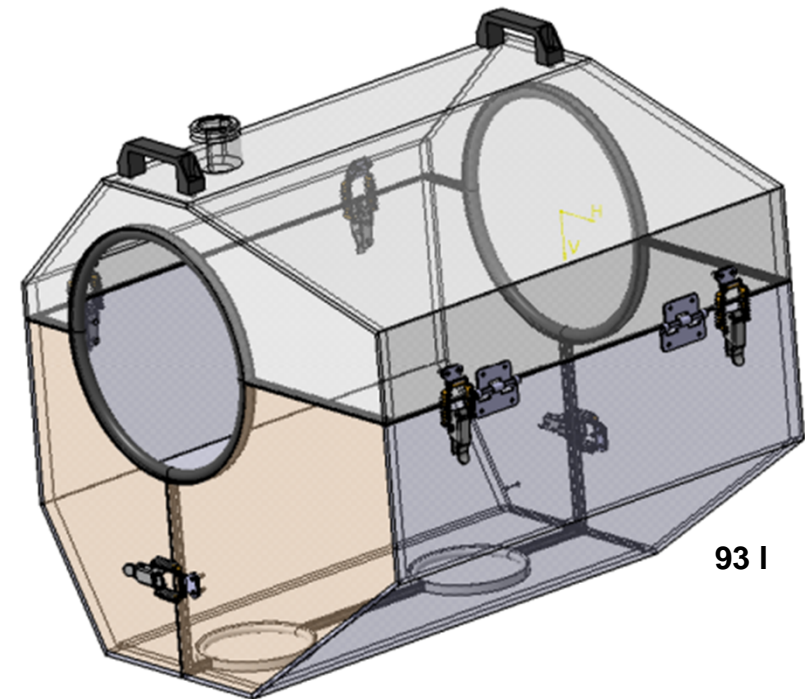
Inter-cavity connection leak-check box, including cold coupler connection

- 1) Pre-fabricated et reusable devices for the leak-check of
 - the cavity string connections → delivery of one prototype on 19/09/2014, needed adjustment, 4 units under fabrication
 - the cold coupler pairs in the clean
- 2) Realization of gate valve support for its assembly on cold-coupler WS:
Design and fabrication taken over by Alsyom, used for XM22.

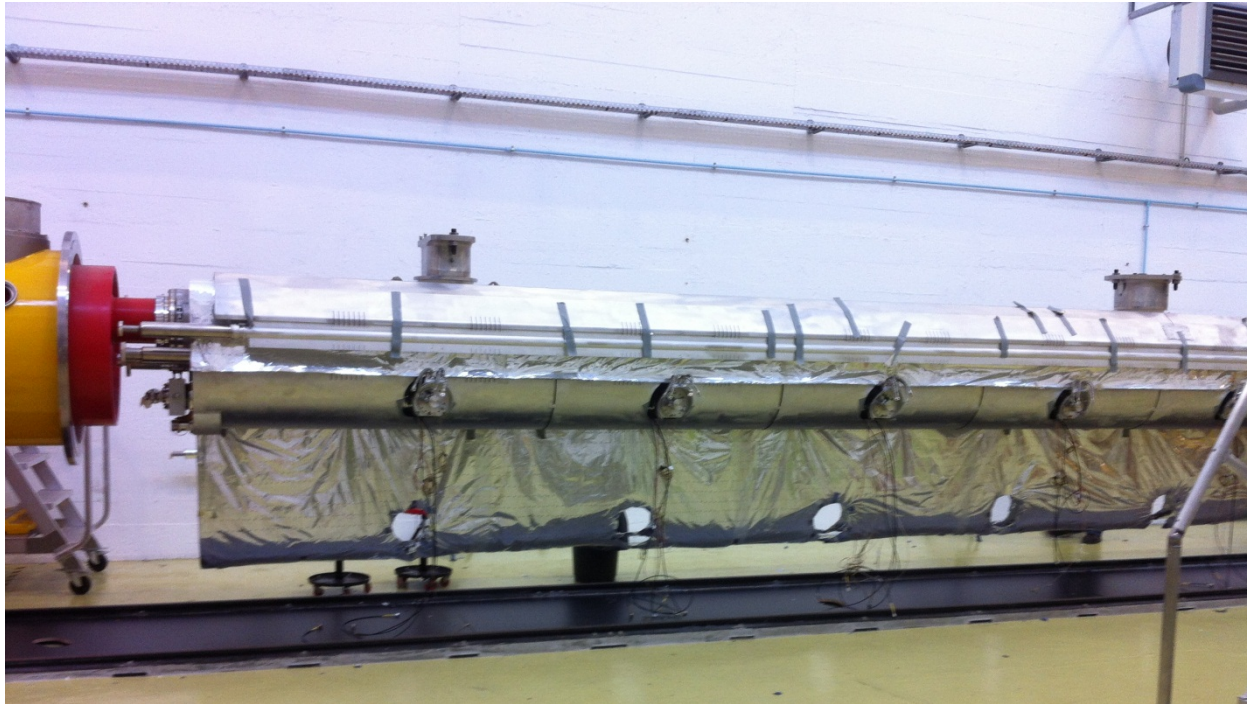
- Cutting coupler holes in the 4K blankets is not an industrial solution, especially when the blanket hangs from the wrong side.

→ Go for pre-cut blankets

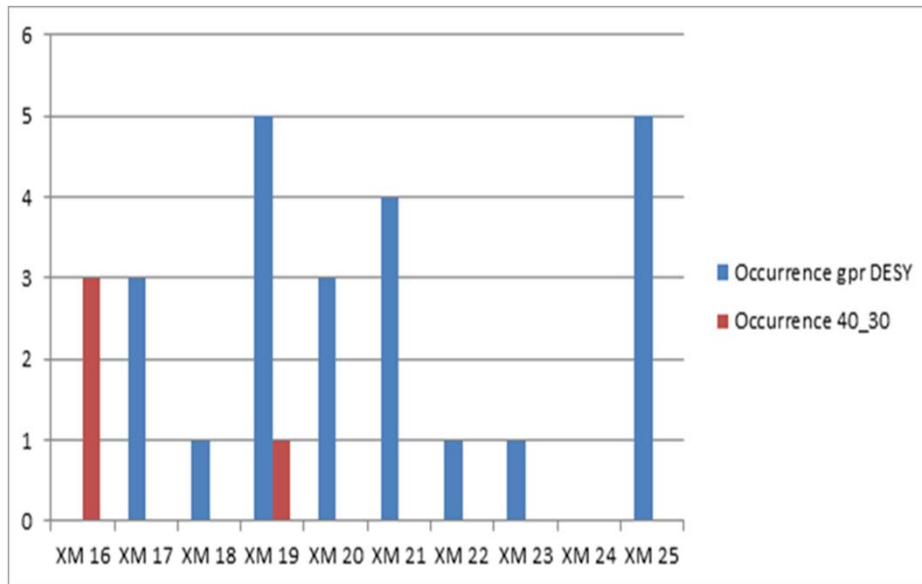
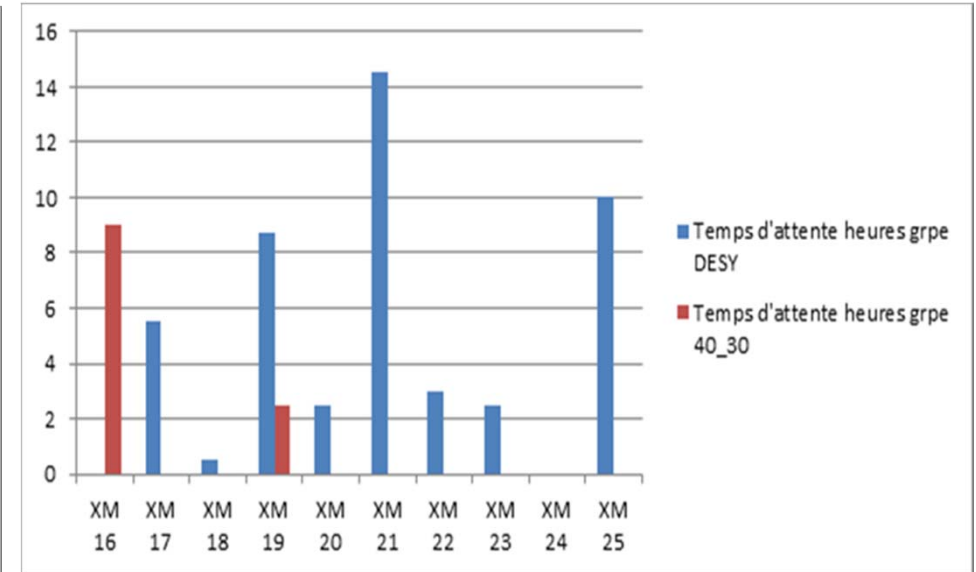
- Higher reliability of vacuum systems is required

On average: 2.7 interruptions of RGA communication per modules, 4.7 hours assembly time lost per module

- Increased productivity with 4 functionalities PUMP, VENT, FLUSH, RGA

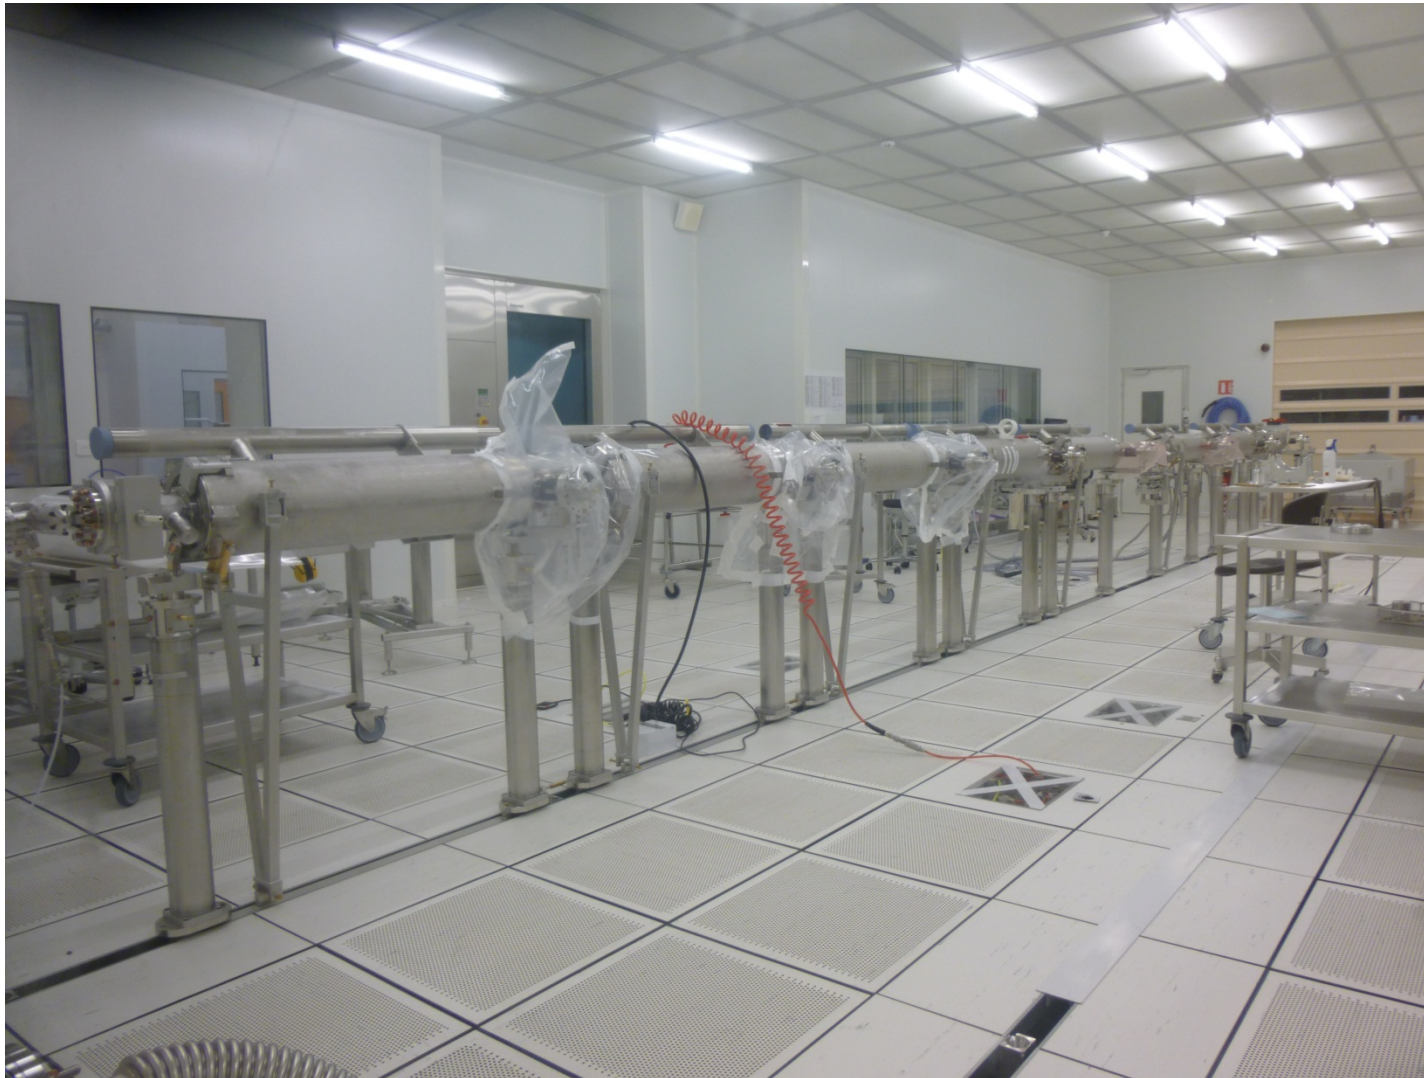
XM4 (String assembly) on 14/02/2014

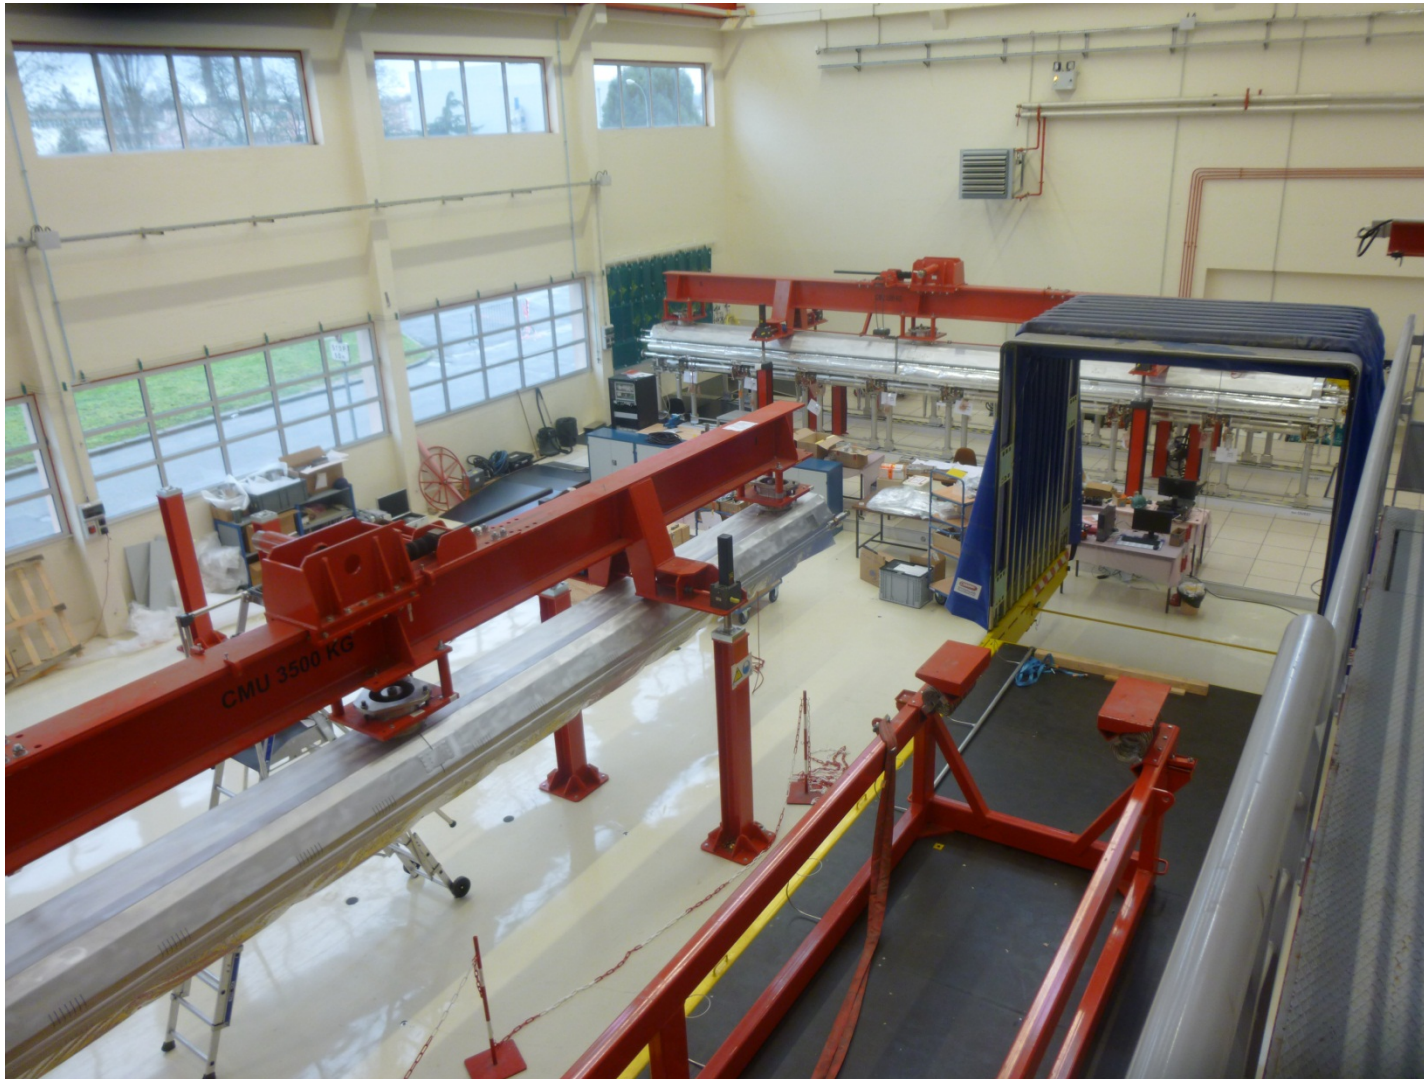
XM2 (Alignment) and XM3 (Roll-out) on 14/02/2014

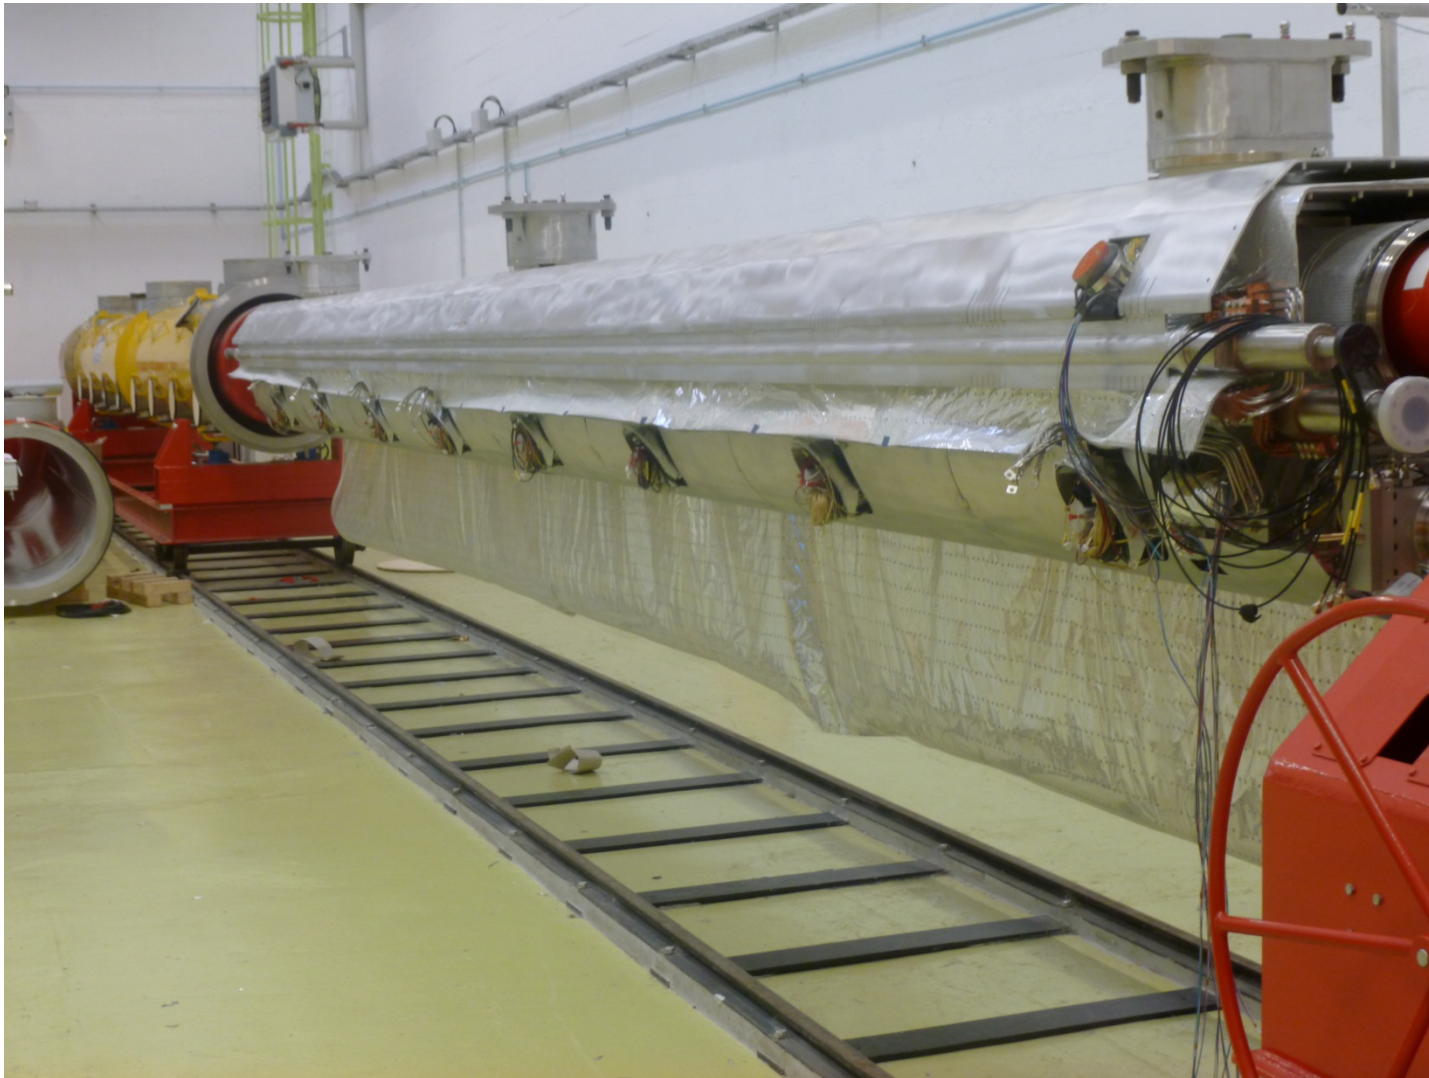
XM1 (Cantilever) on 14/02/2014

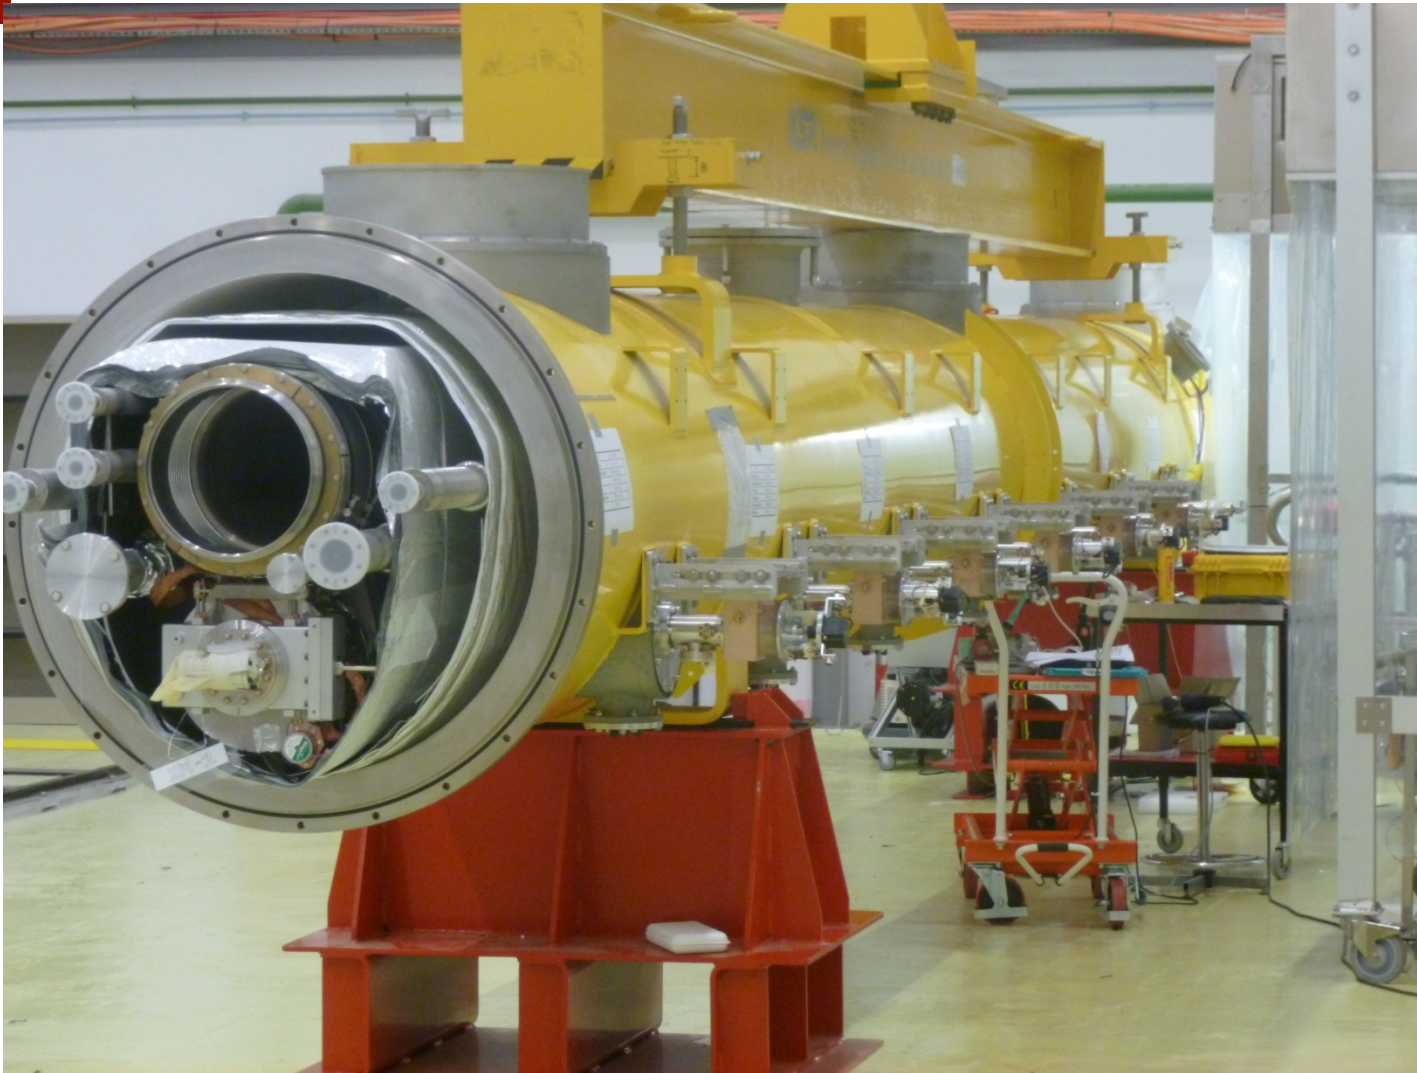
XM-1 (Warm couplers) on 14/02/2014

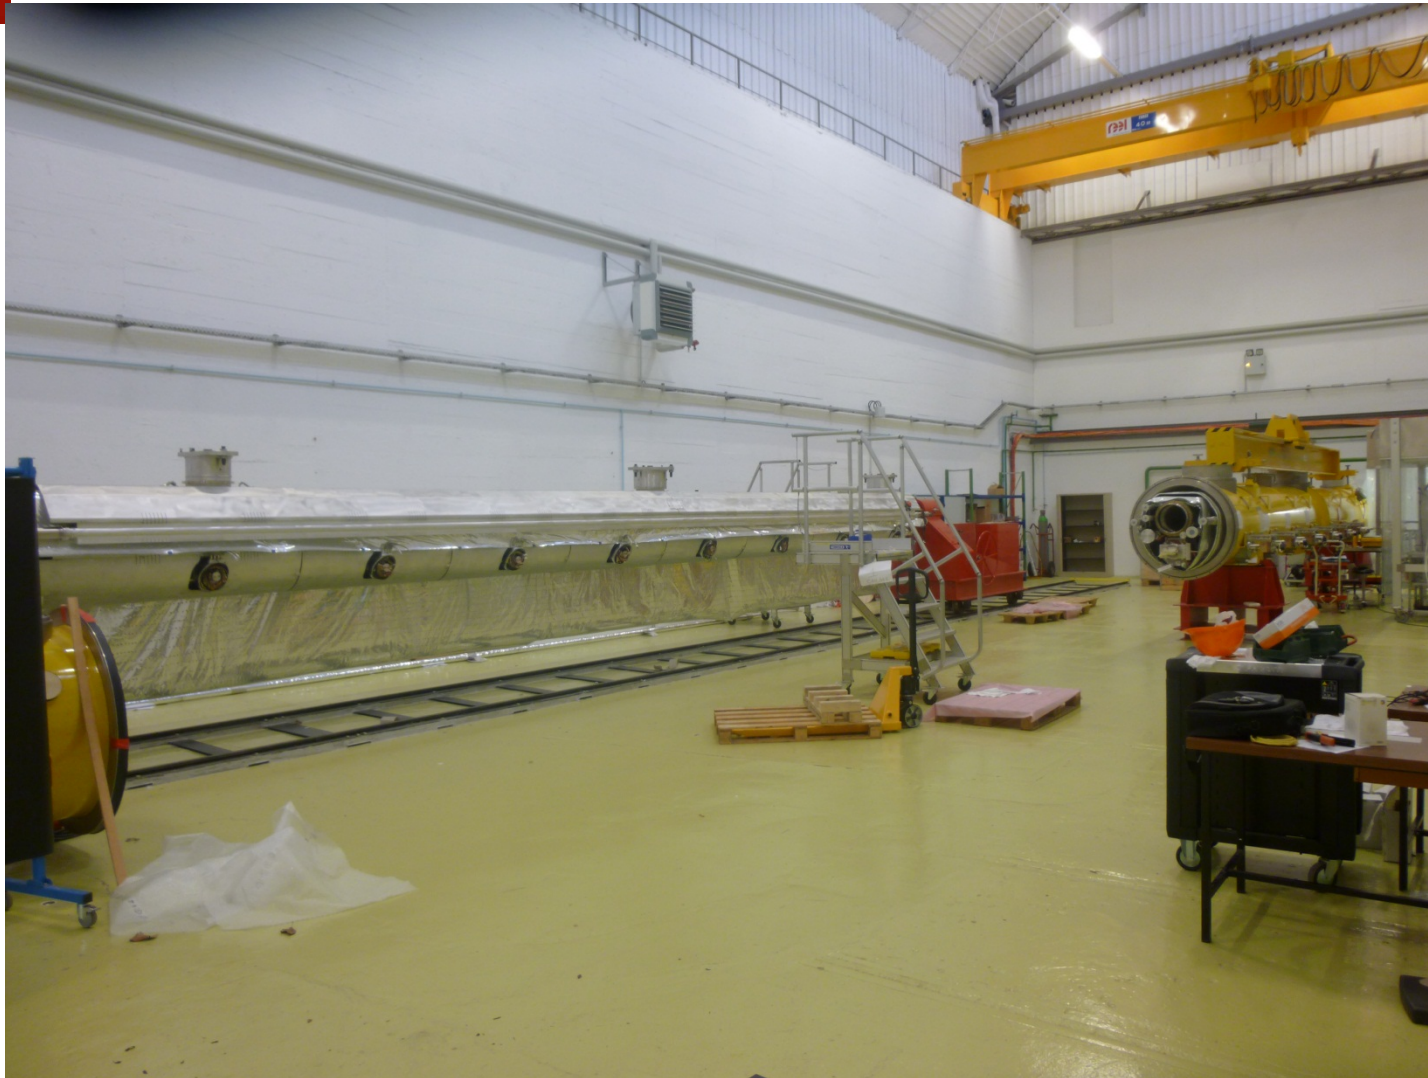
XM1 (Cantilever) and XM-1 (Warm couplers) on 14/02/2014
