Installation epic

Stereo Collaboration Meeting
11 october 2016

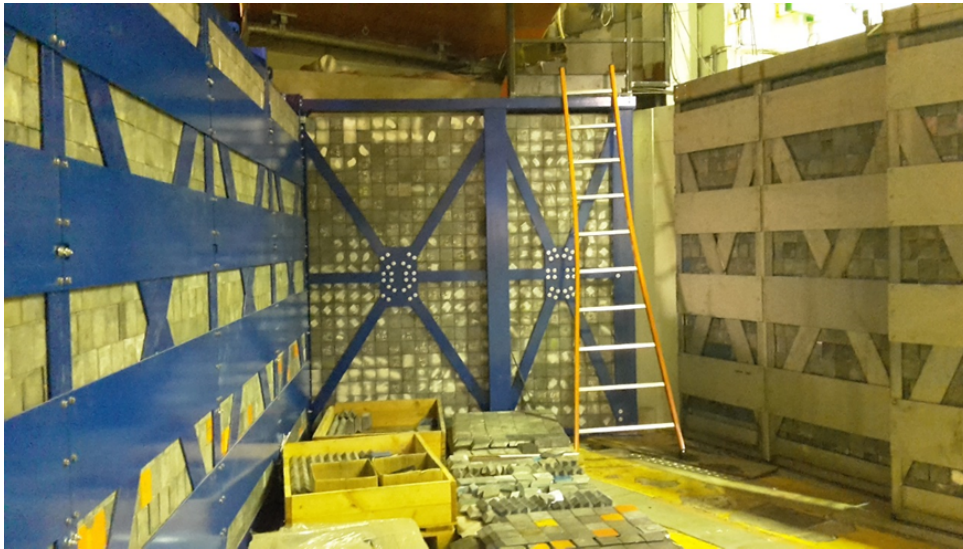
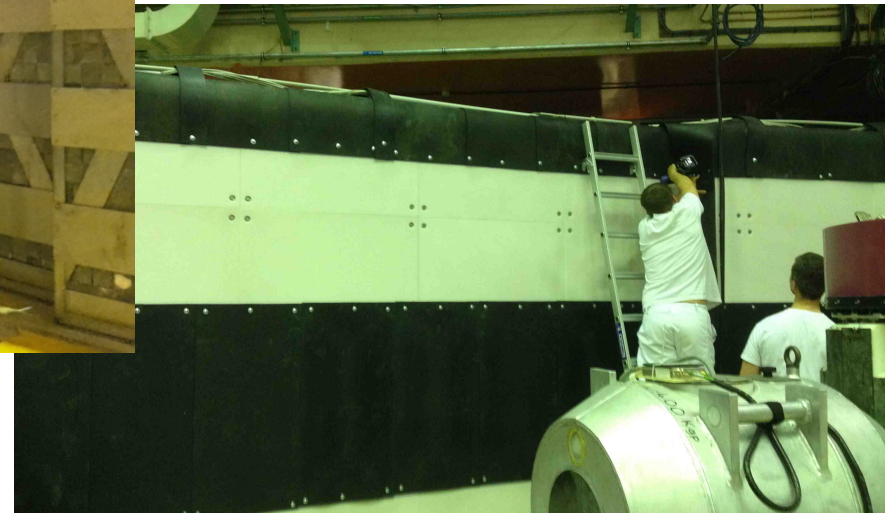
Starting point: Stereo casemate

- D19, Front and IN20 lead walls already installed (10/10/15 cm of lead)
- Borated PEHD (15 cm) + B4C (on top of the wall and at the beam level) on IN20 wall IN20 side.

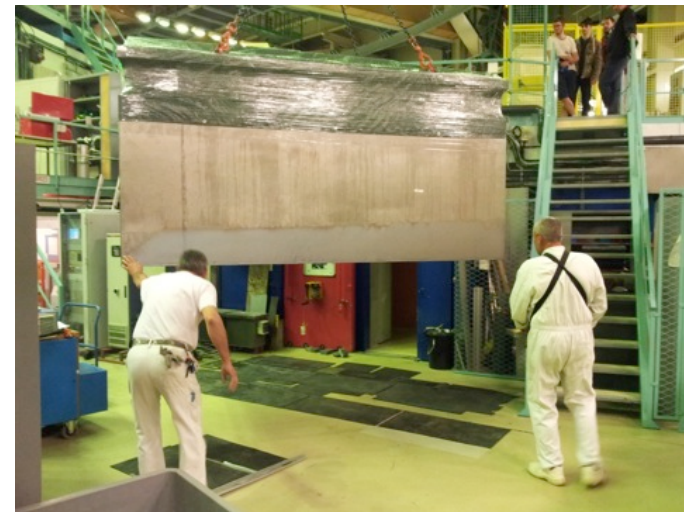
- Large items already entered at ILL
 - Support structure
 - Lead plates: floor (x4) and walls (x6)
 - Detector vessel

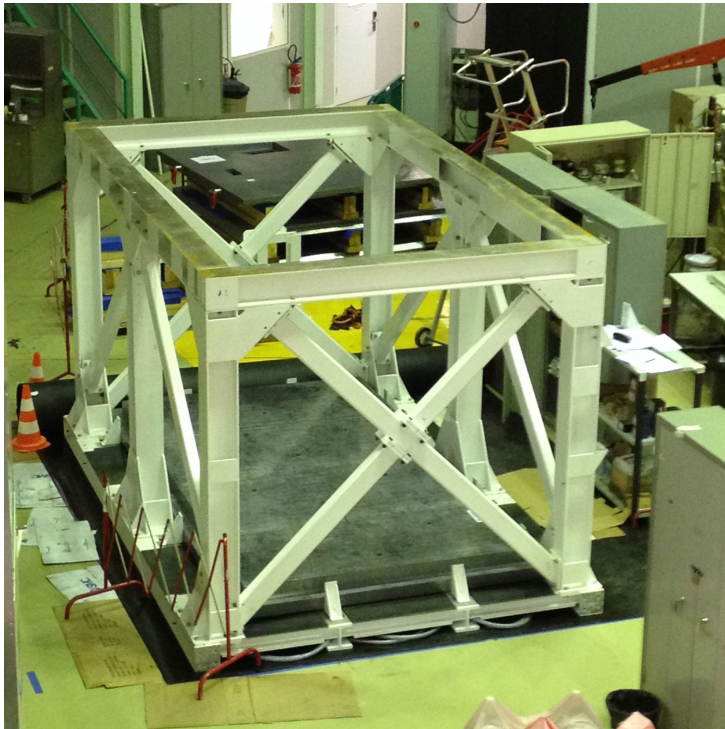
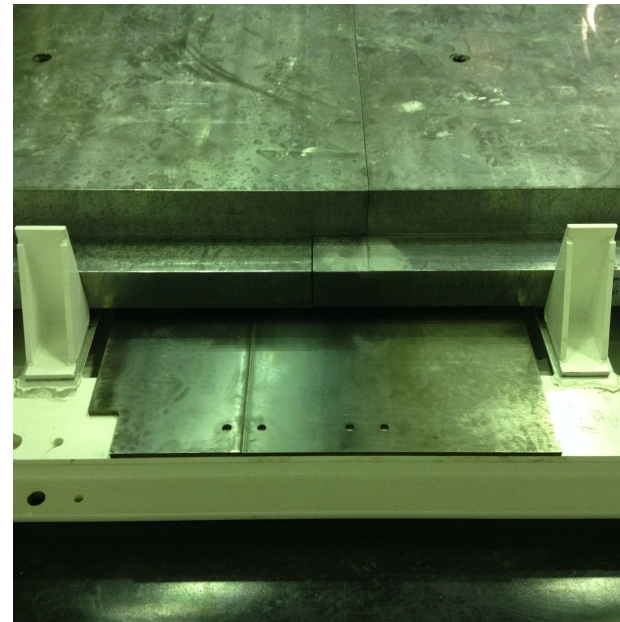
Support structure (LAPP/ILL)

- Setting the support structure on the liner
- Installation of supply hoses for air cushions
- Installation of soft iron (1 cm) and lead (20 cm) floor plates
- Temporary positioning the squares to fix lead walls to the structure

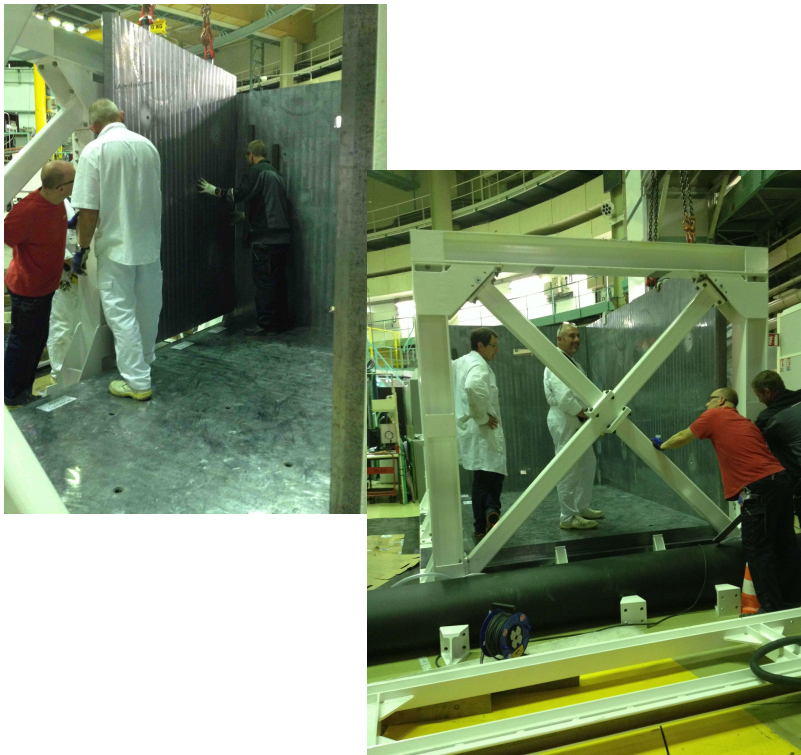
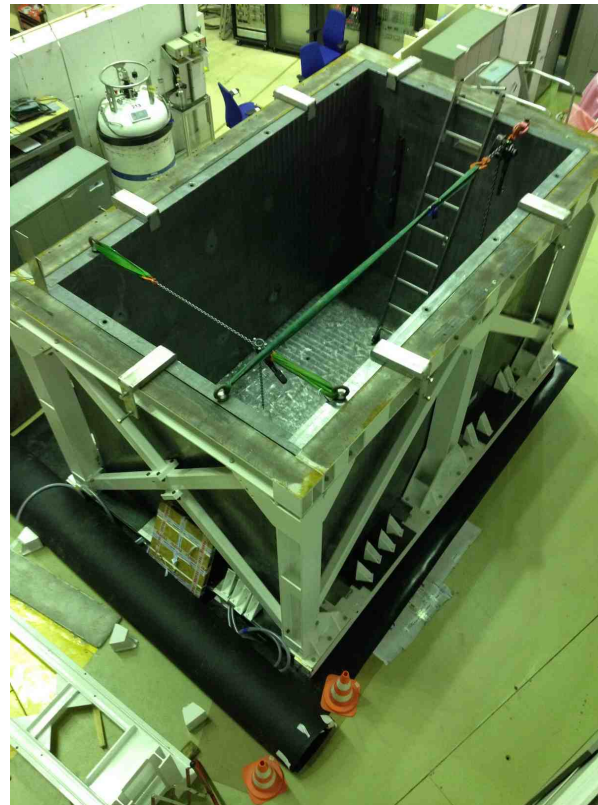
Lead shielding (LAPP/ILL)

- Installation of lead walls
 - 15 cm thick, 1 piece per small side and 2 pieces per long side, 5T/piece
 - residual gap between plates of the order of 2-3 mm on the calibration door side
- Welding support brackets on the structure (qualified subcontractor)
- Filling up handling holes with small lead balls

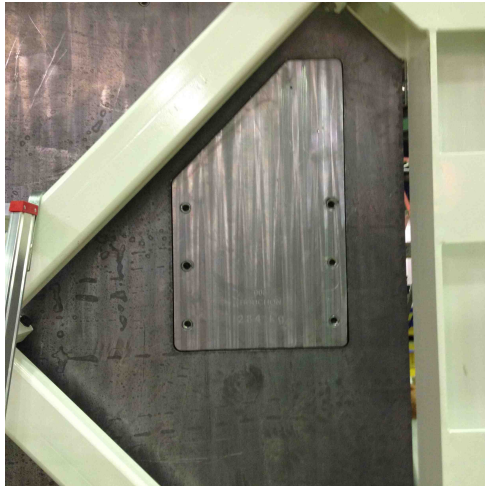
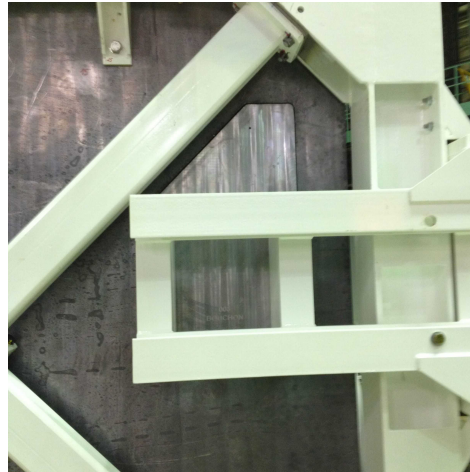
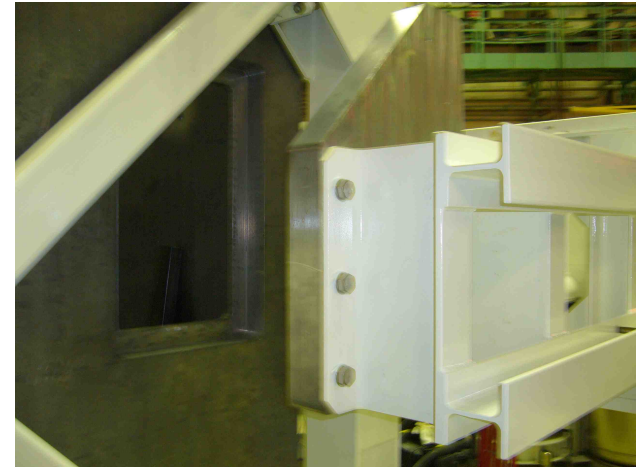
Lead shielding (LAPP/ILL)

- Installation of the arm that support the calibration door (~300 kg)

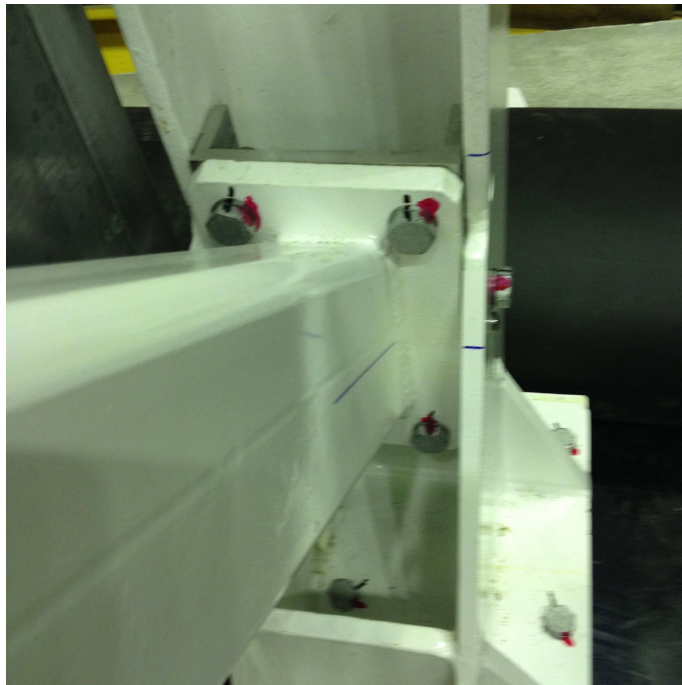
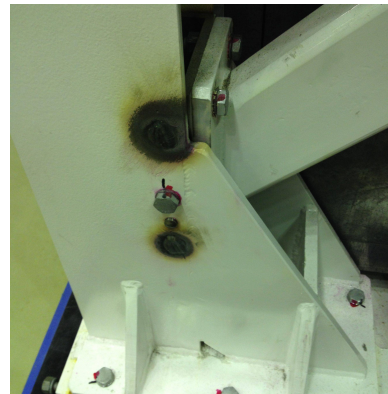
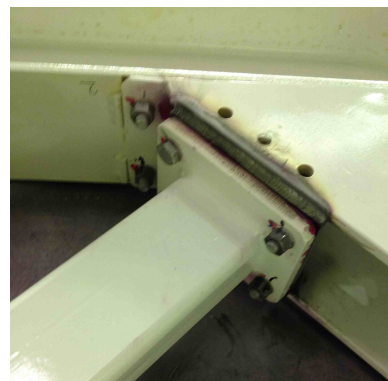
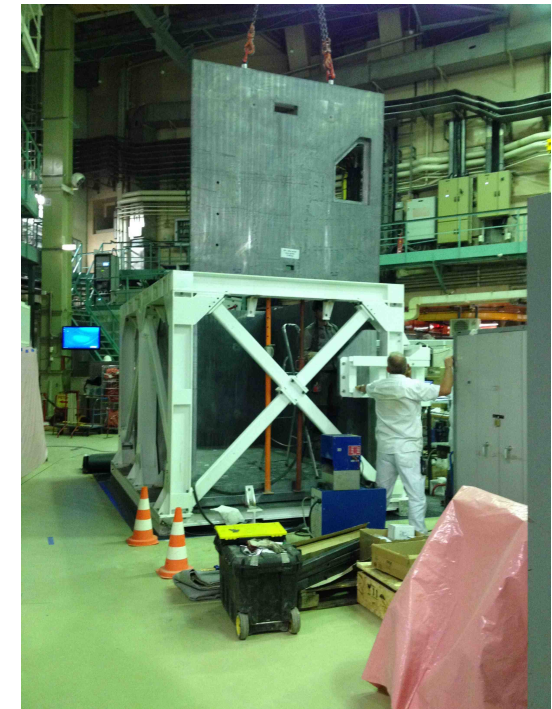
Support structure assembly (LAPP/ILL)

- Need to meet the safety/quality requirements of ILL and NECS calculations
 - Tightening screws to the torque + control
 - Change the assembly of diagonals because of non-conformity on the roughness coeff.
 - The contact surface of the beam was painted instead of being sandblasted
 - Adding one pin in the axis of the diagonal was not enough to fix the U piece
 - Need to weld the U piece on the structure (qualified subcontractor + remove front and rear lead walls during the operation)

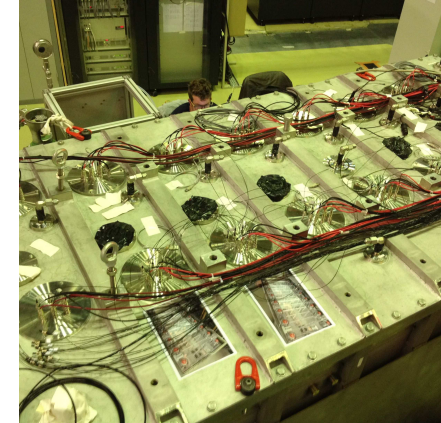
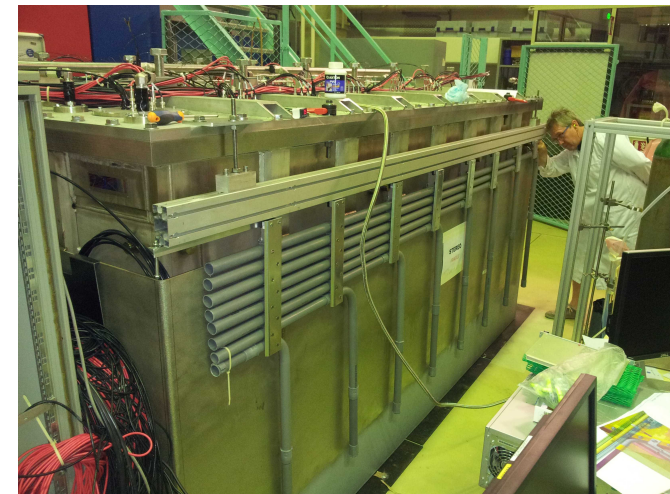
Work around the inner detector (LPSC/Irfu)

- Tests on detector after transportation:
 - All PMT work well (PE and LED runs)
 - New test of light leaks with individual optical fibers
 - Sensors
- Integration of Nomad DAQ in the ILL environment
 - Implementation of data transfer from ILL to LPSC
- Preparation of the detector tubing (filling and calibration tubes) with a mockup
- Detector tightness tests
 - residual leakage of 1.5 mb/h
- Emergency calibration system (plan B)

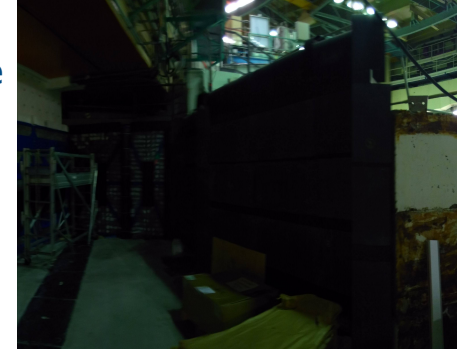
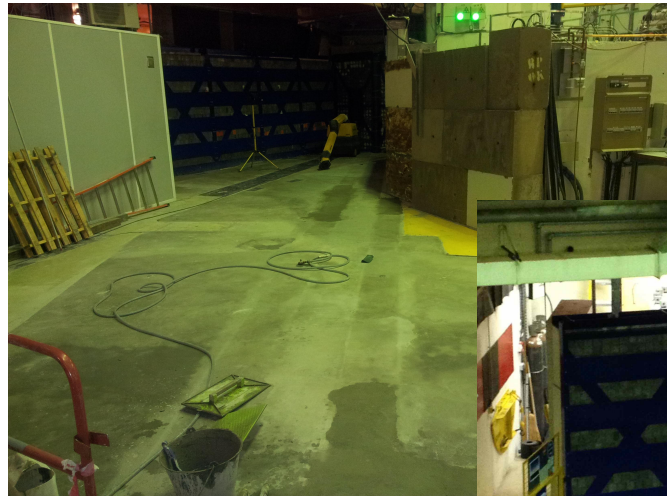
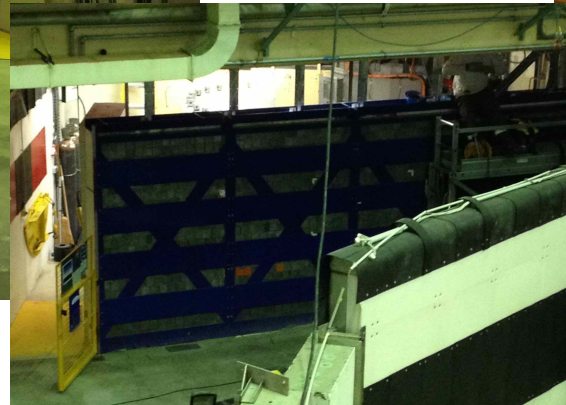
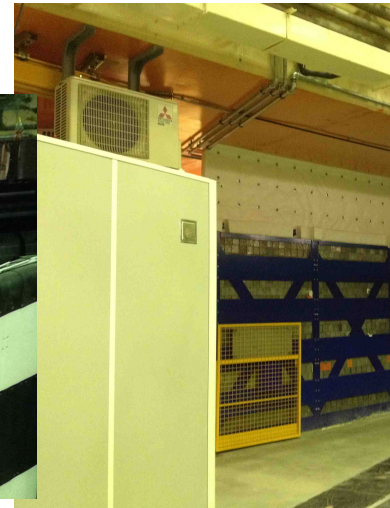
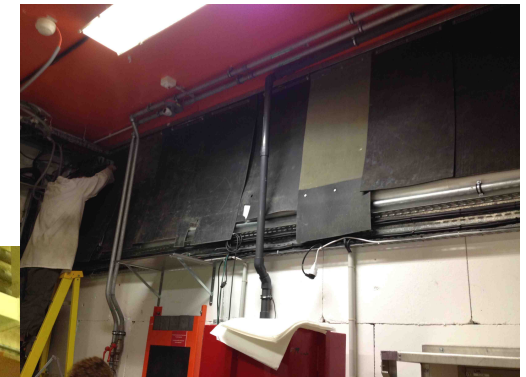
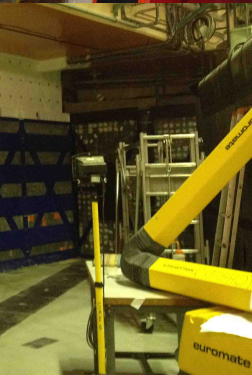
Layout of the casemate (ILL/LPSC/Nuvia)

- Background measurement in the casemate (see F. kandzia talk)
 - IN20 wall covered with B4C (Stereo side) to prevent n-capture on the wall structure
- Work on floor :
 - weld the lid of the cable channel and cover the floor with a flat cement screed
- Installation of the the D19 fire wall on the upper part of D19 wall
 - subcontracted to the NUVIA company (EI120 type with mineral fibers)
 - Cover top of the wall with B4C D19 side

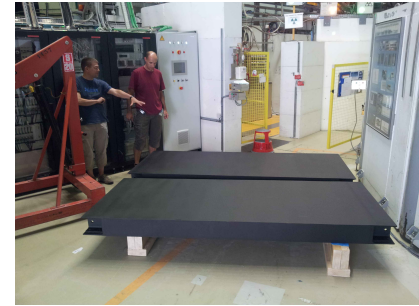
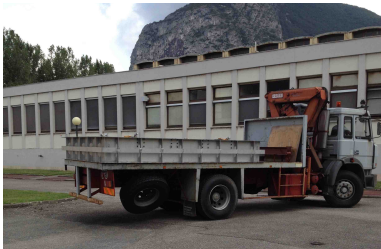
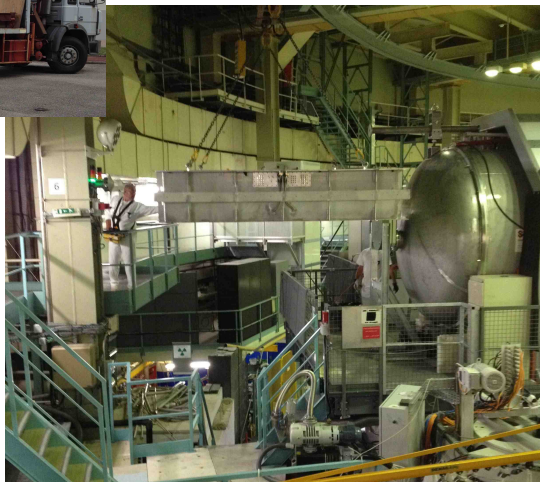
- Lead roof plates (x4) delivered on July 28th
- PEHD floor plates (x2) delivered on August 4th
- Muon veto (4.2 x 2.6 m) transportation from LPSC to ILL on August 8th
 - All PMTs and basis of the muon veto replaced one week before transportation (see J.S Real talk)
- Calibration system delivered at ILL on August 8th
 - Position encoder to be replaced
- PEHD walls (x6) and roof (x6) plates delivered on August 18th

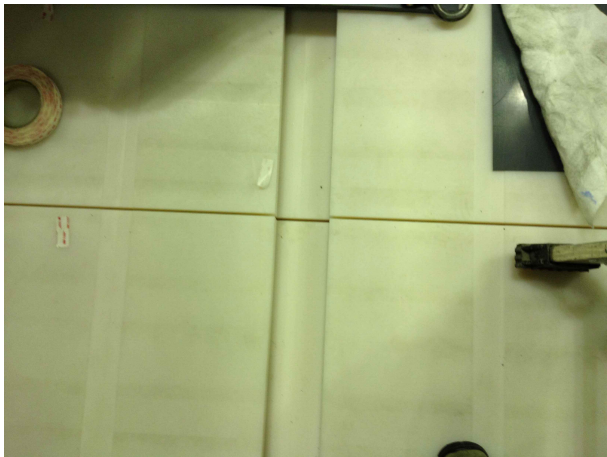
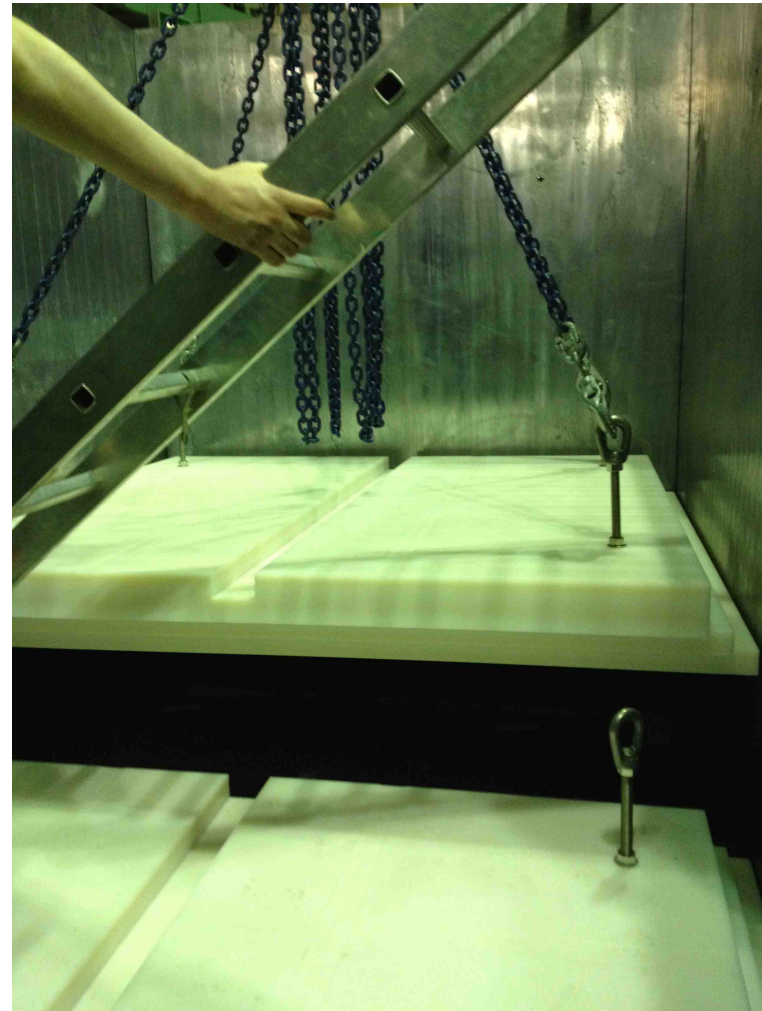
PE shielding: floor (LPSC/ILL)

- PEHD floor :
 - 20 cm of borated PEHD 500
 - one channel for calibration rail (90x50)
 - 2 plates, 5 mm gap for T dilatation
 - Handling nuts (stainless steel) not removed from PEHD
 - Filling up handling holes with PEHD plugs

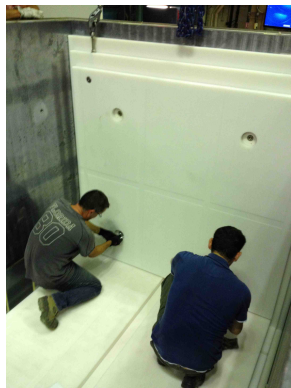
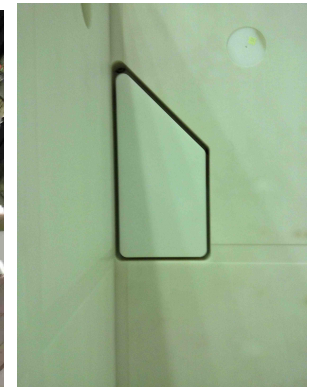
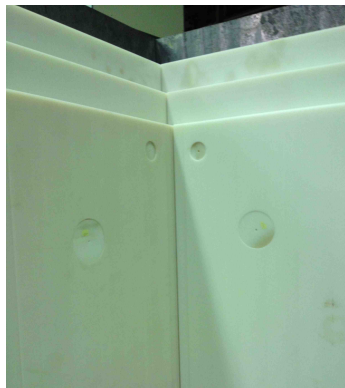
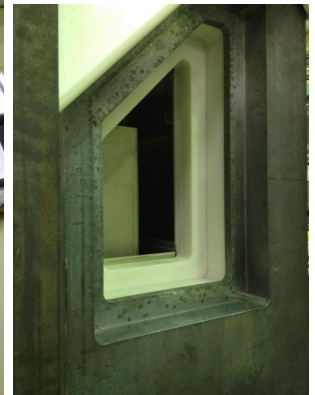
- Installation of borated PEHD walls (15 cm)
- Fixation of walls on lead plates with double eccentric system
 - One hole in lead was not well placed -> drilling a new one and filling up the old one with lead chips
- Removing handling nuts and filling up all handling and eccentric holes with PEHD plugs

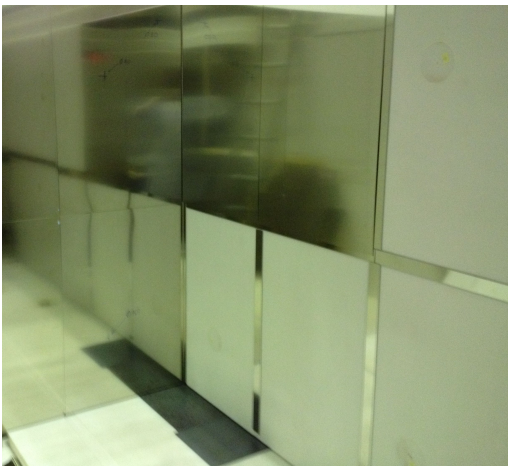
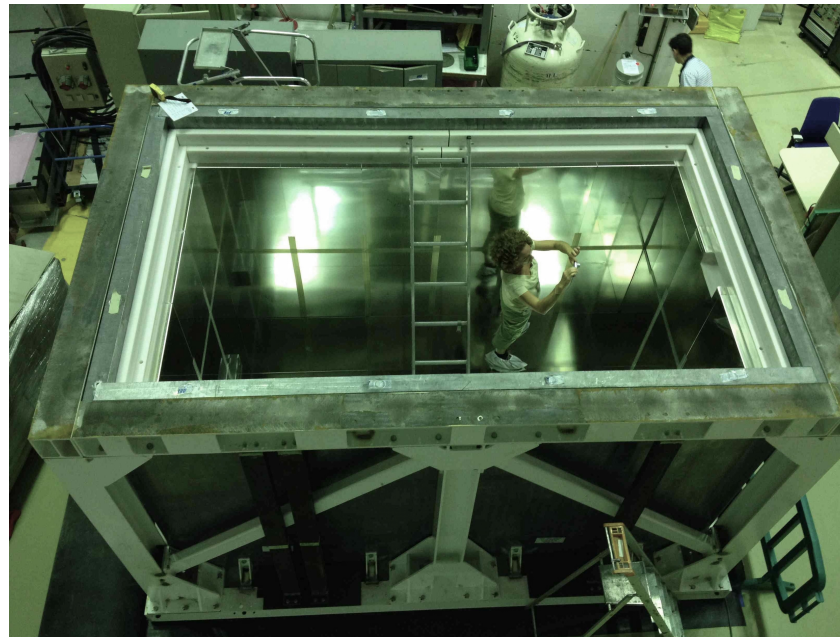
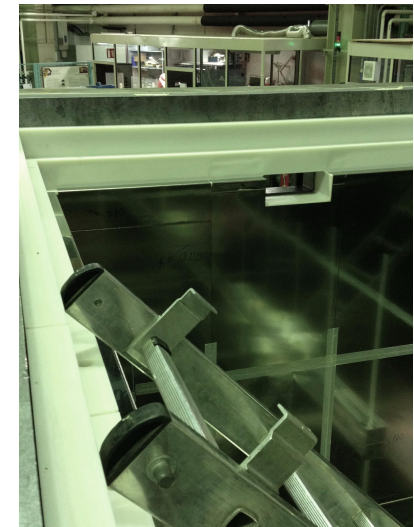
Mu-metal Shielding (LPSC)

- Install mu-metal shielding (1.5 mm thick) on PEHD with double sided tape
 - recovering bands and angles (4 cm wide) are inserted in small grooves in PEHD
 - Mu-metal Plates are folded on top and bottom for better connection with floor and roof plates
 - Need to cut 2 plates because they were folded wrong side
- Add PE sliding tape between plates to avoid interferences with calibration system

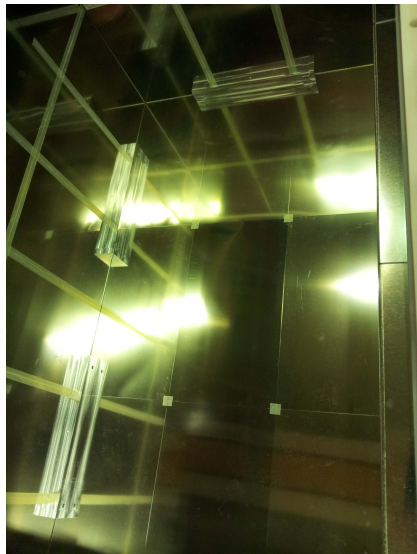
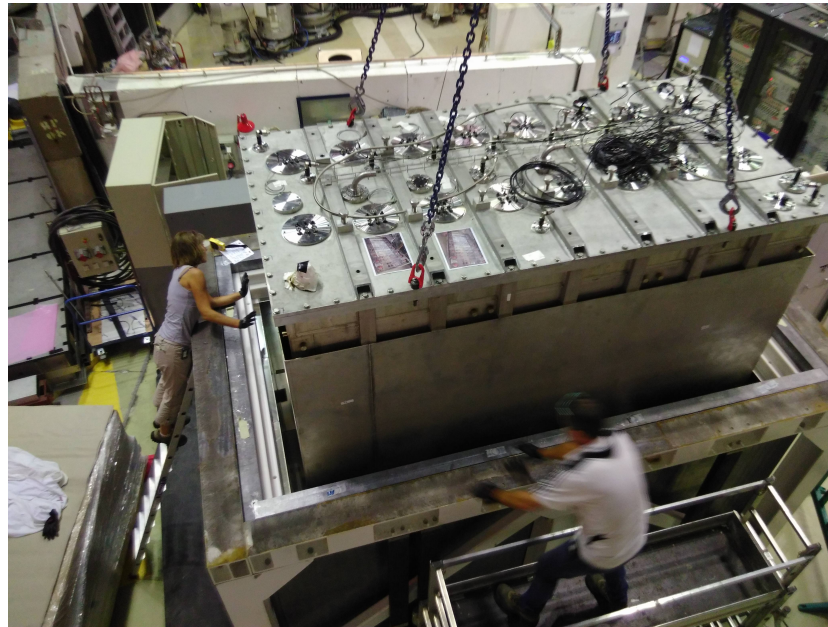
Detector insertion (LPSC/Irfu/ILL)

- Shielding ready for detector insertion on august 25th
- Installation of fixed blocks on the floor for detector centering
- Insertion of the detector
- Installation of adjustable centering blocks on the other sides: detector in contact with all blocks

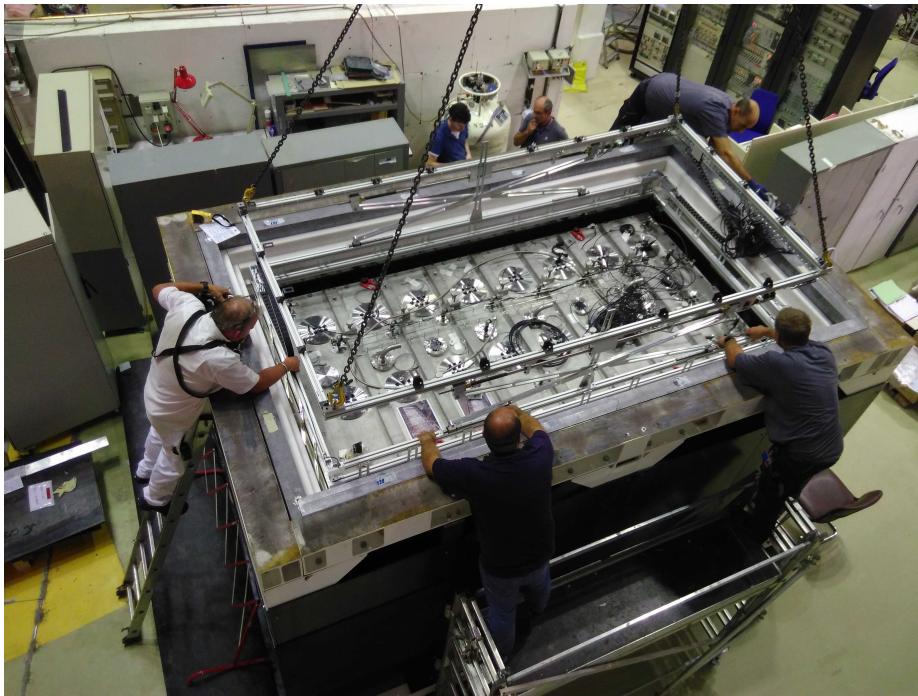
Insertion of the Calibration system (LAPP/ILL)

- Changing position encoder (X-Y plan) on the pantograph
 - Hysteresis is still there when the source is on the return path (see P. Del Amo Sanchez talk)
- Insertion of pantograph calibration system on August 31th
 - mechanical gaps between detector and shielding meet specifications
 - Displacement of the source holder inside shielding (with prototype control system) checked

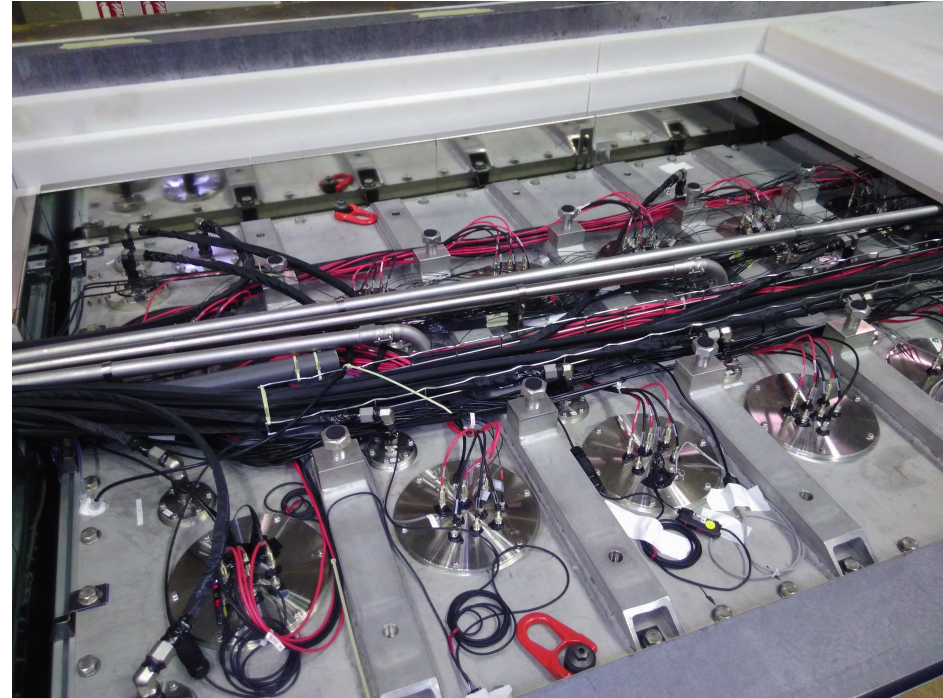
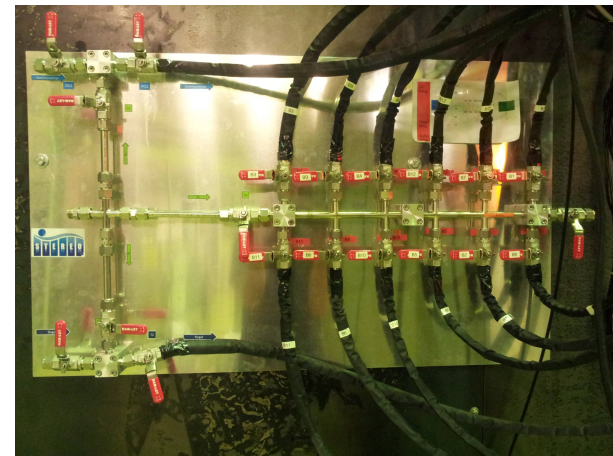
Detector cabling and tubing (LPSC)

- Cabling the detector
 - 48 PMT HV + 48 PMT signal
 - 36 Optical fibers / 4 bundles
 - Sensors
 - 12 cameras
 - 3 level-stop
 - 4 PT100
 - 2 Pressure (abs+diff)
 - 4 ATM (level P/T)
 - Control command for the pantograph
- Tubing
 - 3 calibration tubes
 - PFA filling pipes
 - 1 GC, 1 TG, 12 buffers
 - covered with shrink tubes
 - Exhaust
 - Emergency emptying
 - One tube for He3 or fluxgate detector
- Testing detector before closing:
 - PMT + optical fibers
 - Sensors
 - Tightness after tubing and installation of the liquid panel $\rightarrow 1.5 \text{ mb/h}$

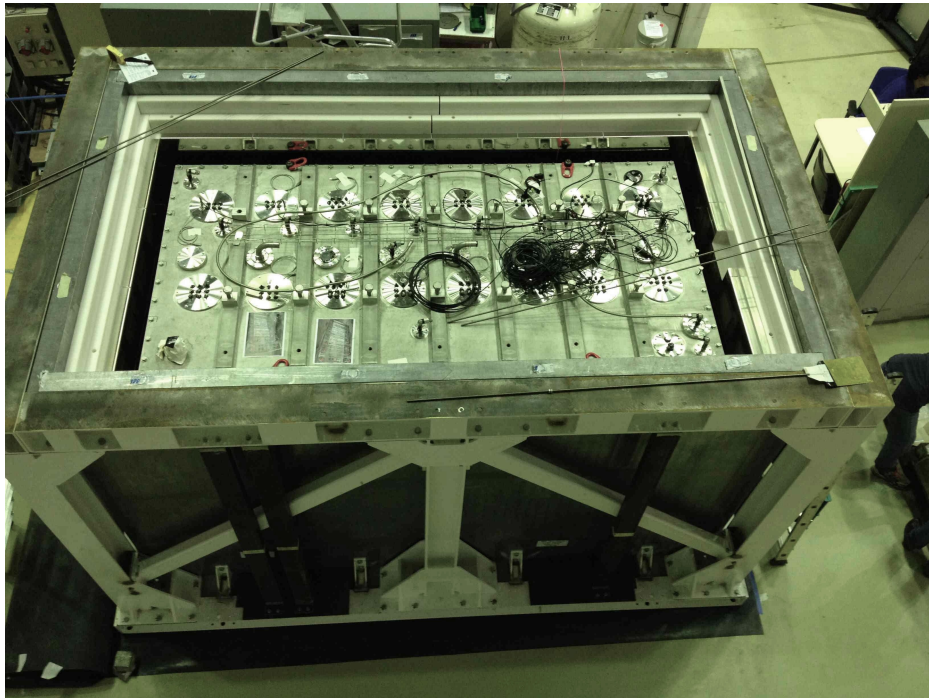
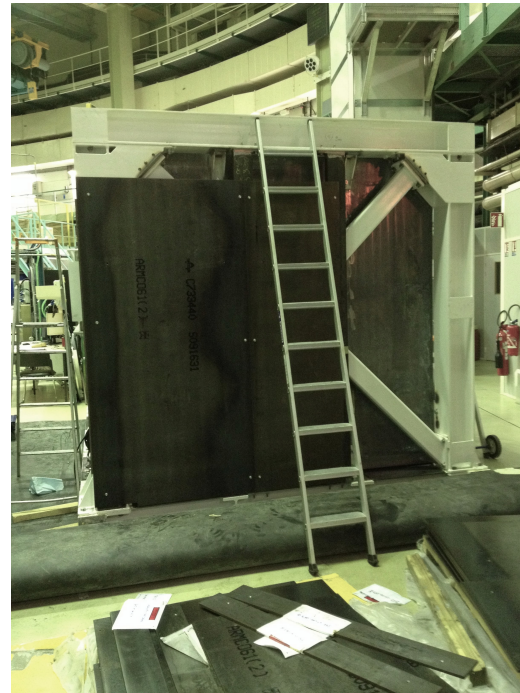
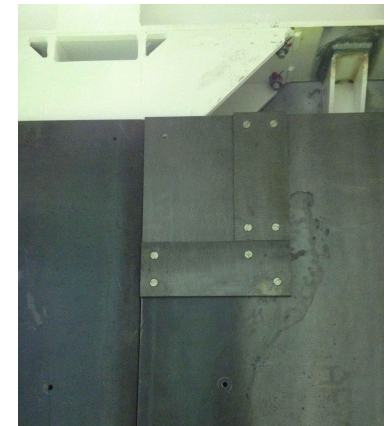
Soft iron shielding (LPSC/ILL)

- Installation of soft iron (1 cm) in the lower part of the shielding started on August 26th
 - Delayed because some plates were damaged during transportation (fell off the truck) → Patch on 2 plates
- Additional beams were fixed on the structure to support soft iron plates
- Fixation with thread-forming screws

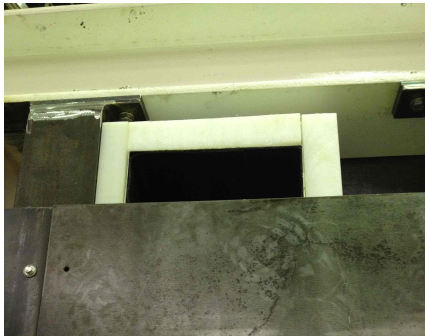
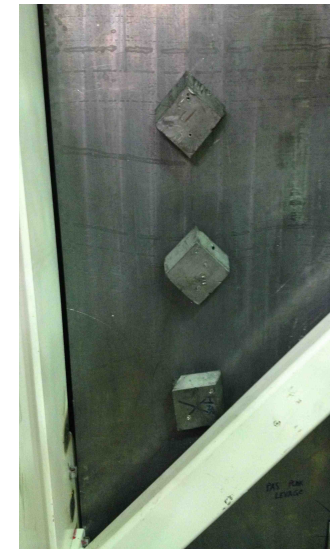
- Adding PEHD around passages through shielding
 - Passage of cables and calibration rail
 - Add B4C around the passage of cables
- Filling up holes dedicated to emergency calibration system
 - PEHD round bars + rolled lead sheets + lead bricks

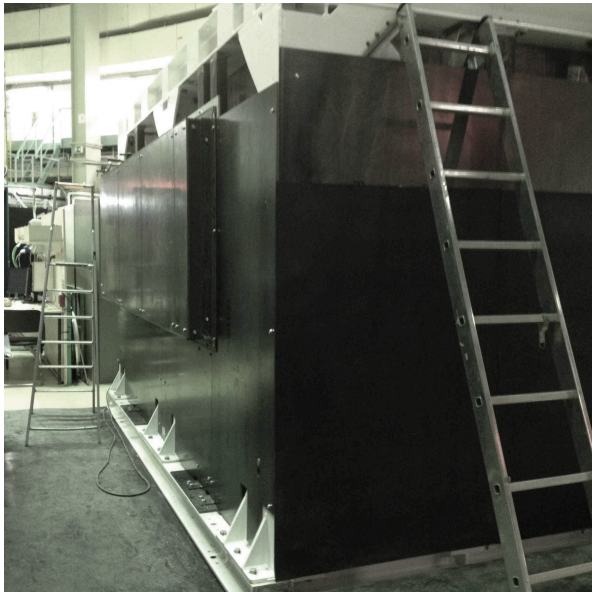
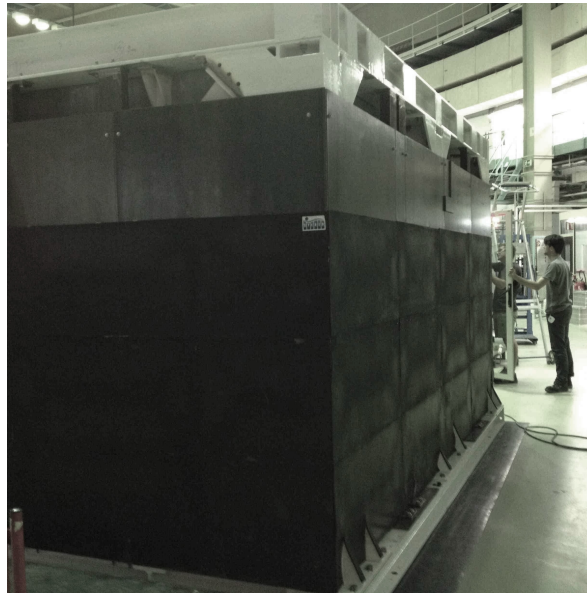
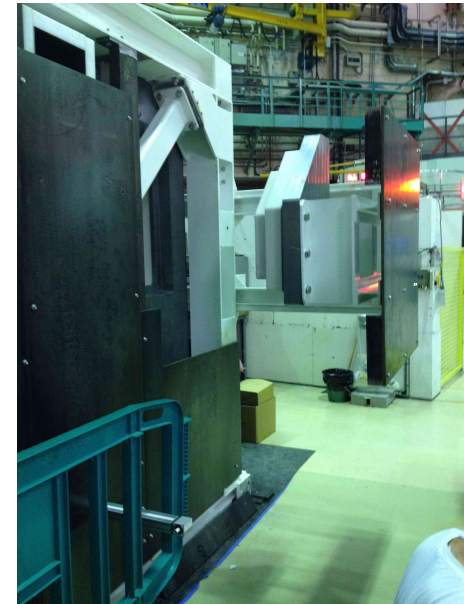
Soft iron and B4C shielding (LPSC/ILL)

- Covering soft iron with B4C (5 mm)

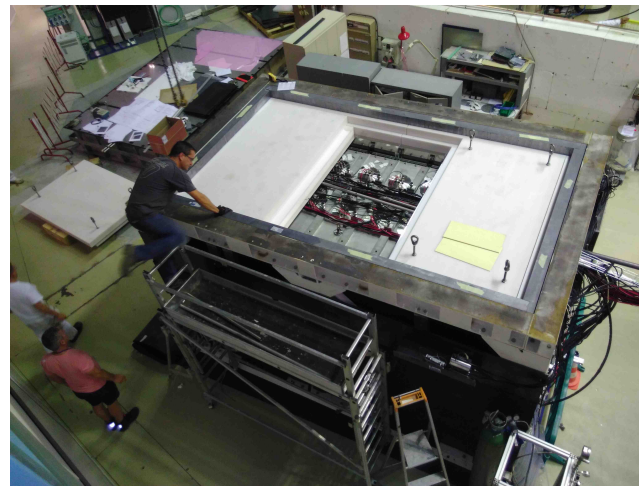
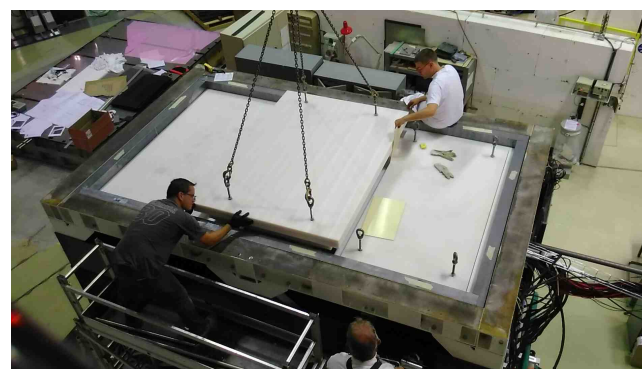
Closing the shielding: PE roof (LPSC/ILL)

- Closing PEHD shielding on September 6th
 - 29 cm in 2 layers (20 cm + 9 cm)
 - Mu-metal glued on PEHD roof plates before insertion
 - Gap between detector and PEHD roof meet specifications

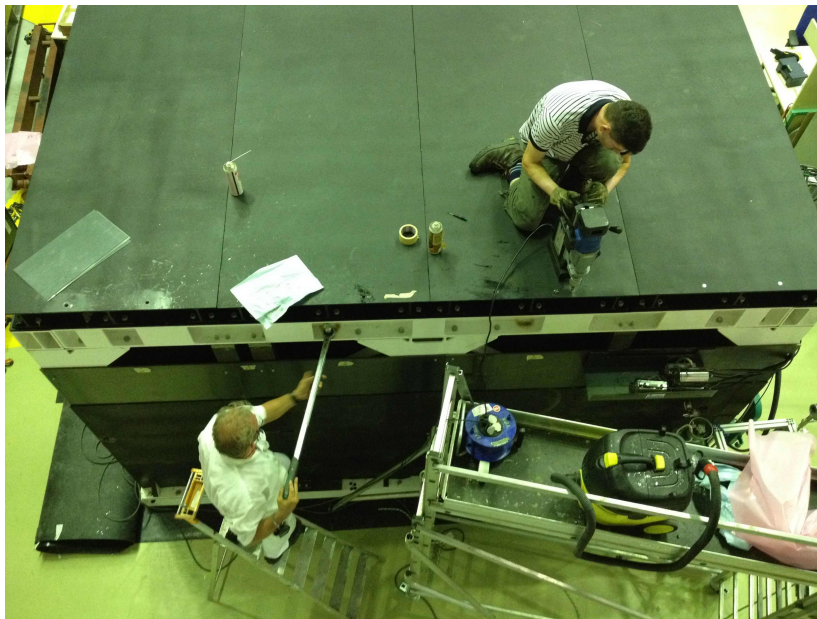
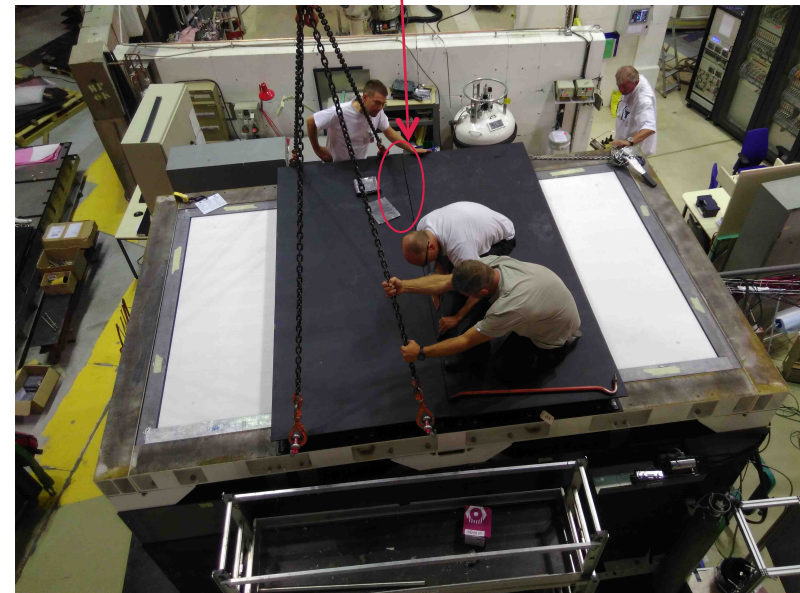
Closing the shielding: Lead roof (LAPP/ILL)

- Installation of lead roof plates (15 cm lead) on September 7th
 - Screwing lead roof plates to the structure
 - Tightening screws to the torque + control
 - No chicane between plates :
 - 1mm gap between the 2 center plates, IN20 side
 - Gap partially filled with 1 mm lead sheet

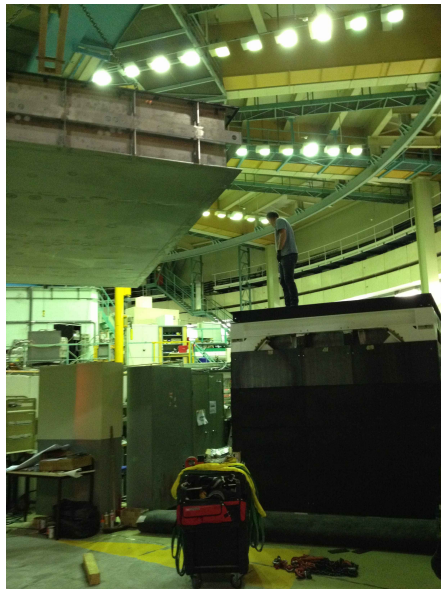
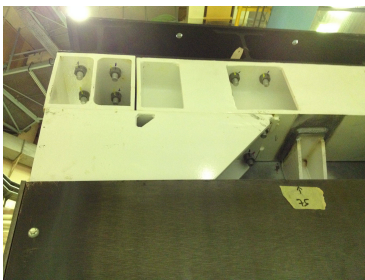
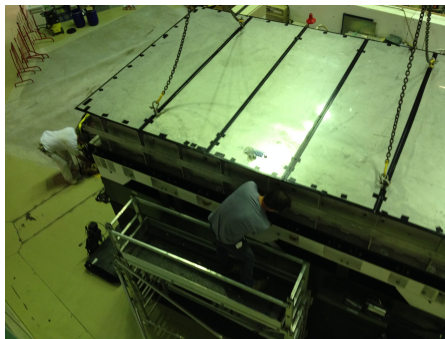
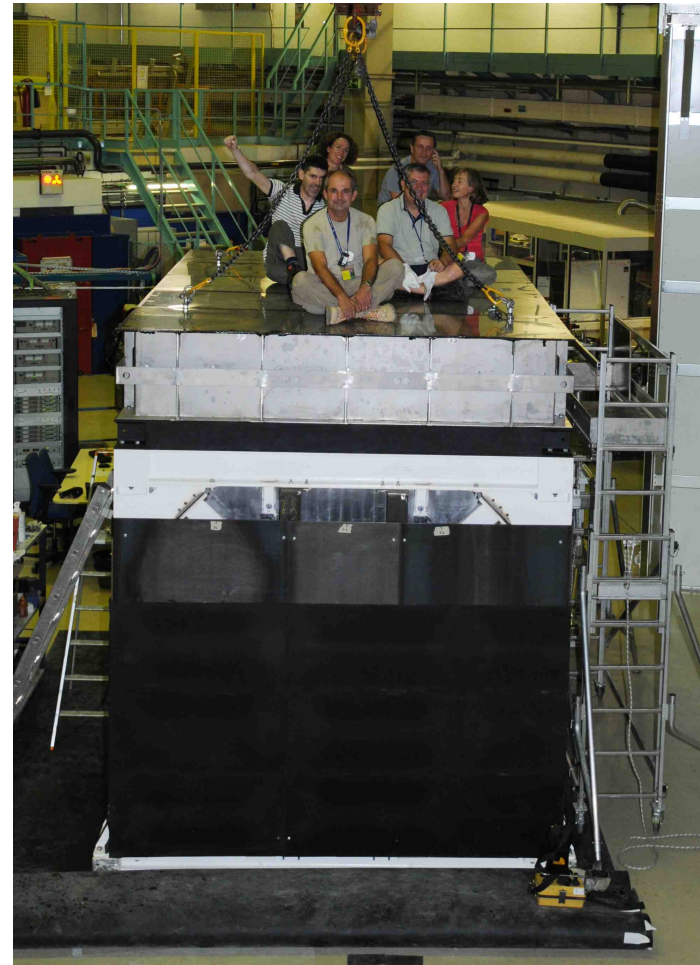
Installation of the muon veto (LPSC/ILL)

- Installation of muon veto on the lead roof on September 9th
 - Veto screwed on lead roof

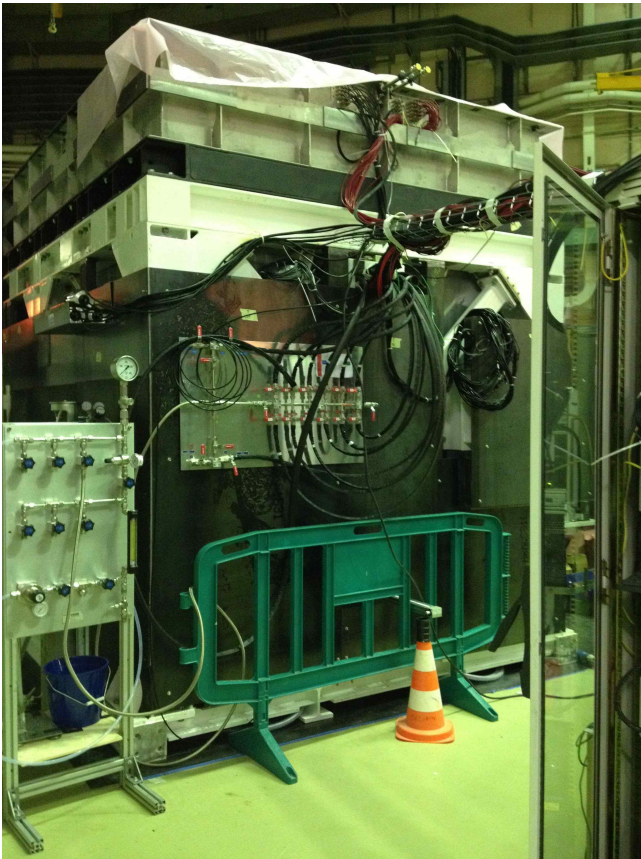
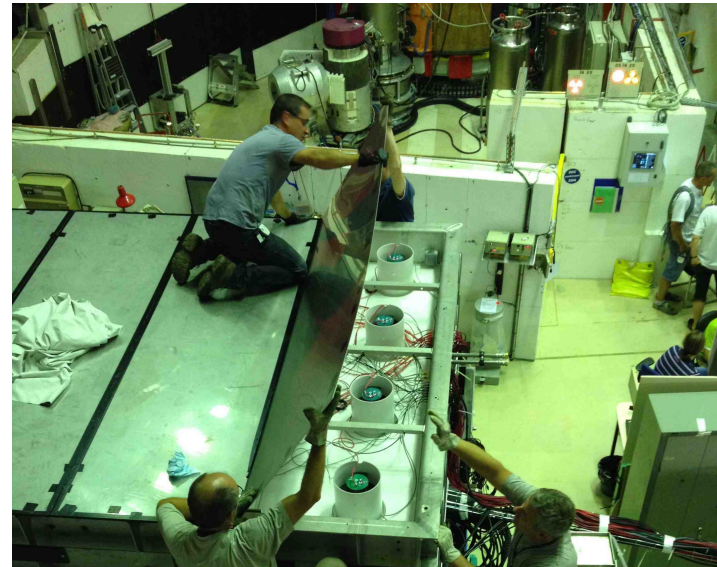
Installation of the muon veto (LPSC/ILL)

- Cabling the muon veto : PMT (x20) HV+Signal, optical fibers (x12), sensors (2 T and 4 level)
- Test all PMTs
 - One PMT broken during installation (evaporation of the photocathode) → change the PMT on site
 - The basis died 2 days latter → change the basis

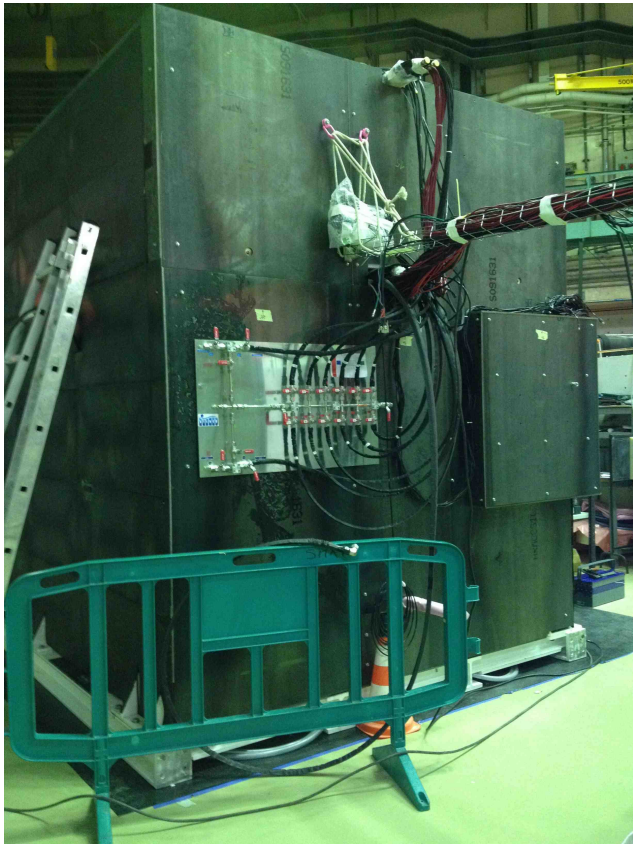
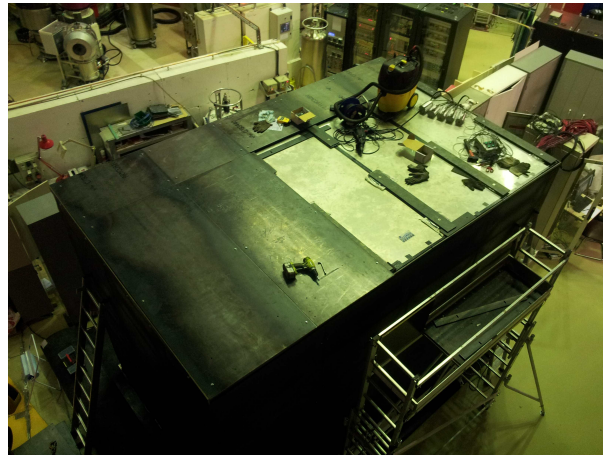
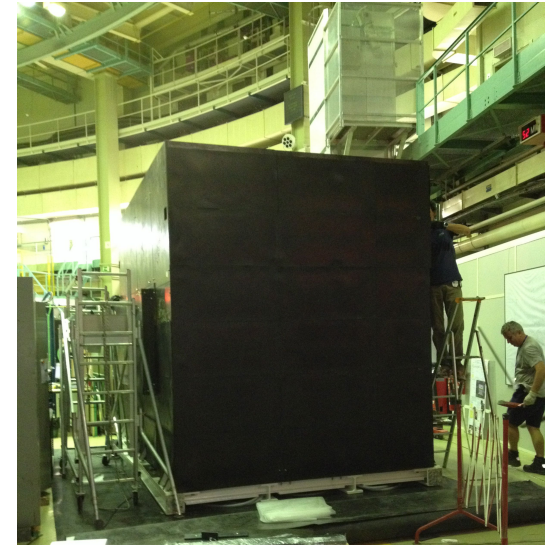
Soft iron shielding (LPSC/ILL/irfu)

- Installation of the soft iron + B4C shielding in the upper part of STEREO
 - Fixation around and above the veto with dedicated wedges
- Fixation of LED boxes

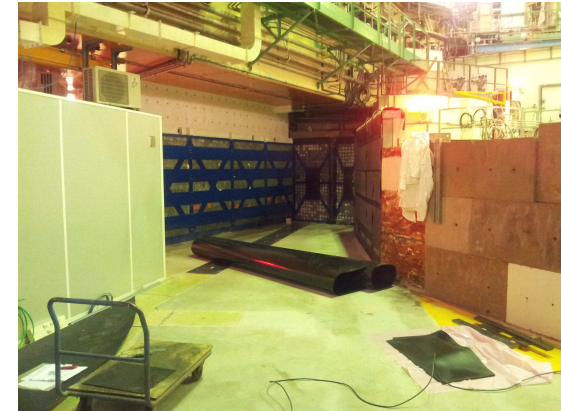
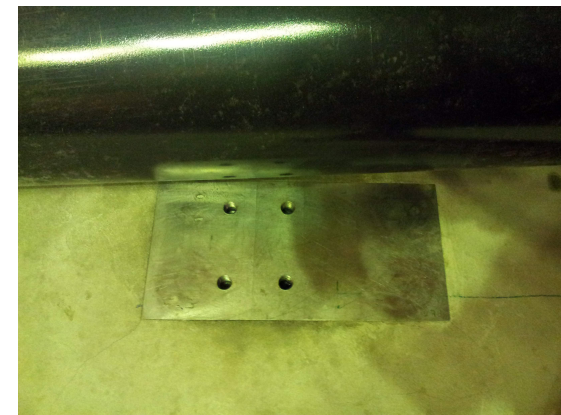
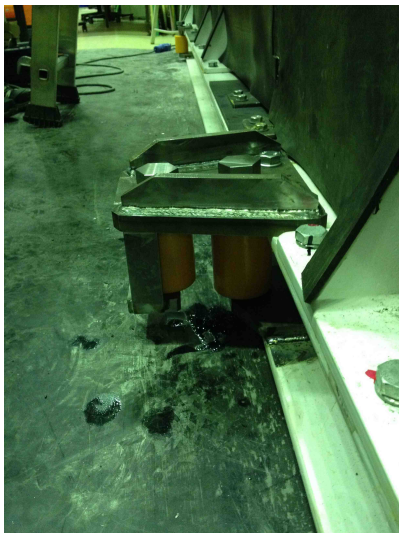
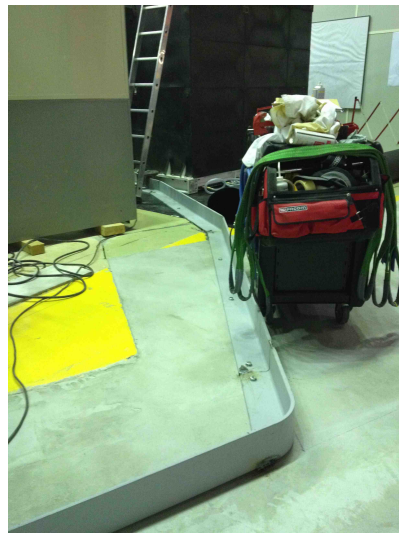
Preparation for detector move (ILL)

- Installation of the guiding systems:
 - on the structure (produced at MPIK workshop)
 - rails on the floor
 - anchorage points for winches
- Installation of the liner in the casemate
- Drilling the connector board for STEREO anchorage on floor

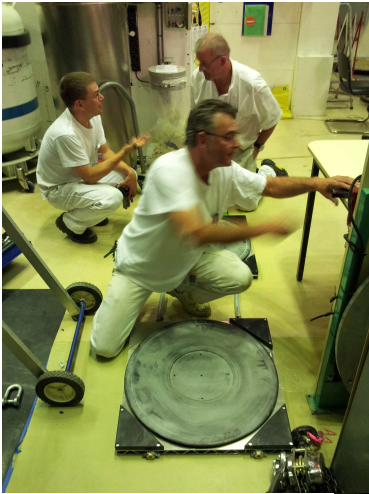
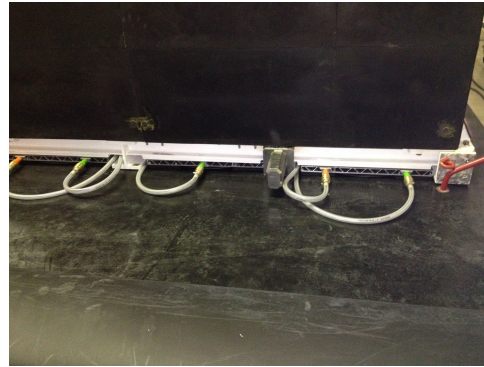
- Feed through for compressed air was already ready
- Air cushions delivered just in time on September 21th
 - Need to adjust the height
- Introduction and connection of air cushions (x10) underneath STEREO
- Connecting the 2 control desks to compressed air
