Installation epic

Stereo Collaboration Meeting
11 october 2016

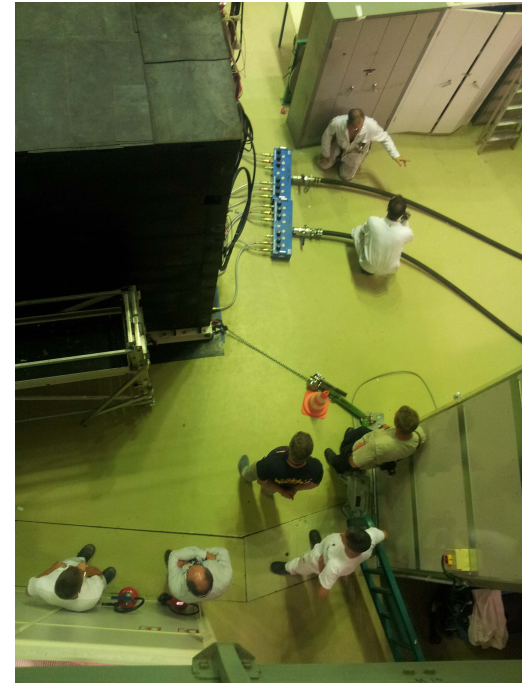
Preparation for detector move (ILL)

- Feed through for compressed air was already ready
- Air cushions delivered just in time on September 21th
 - Need to adjust the height
- Introduction and connection of air cushions (x10) underneath STEREO
- Connecting the 2 control desks to compressed air

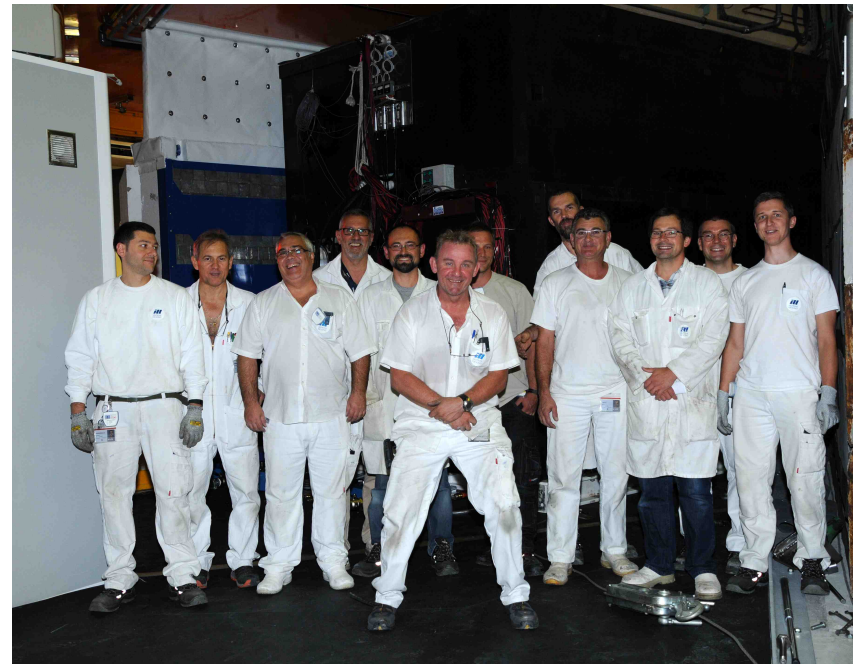
- STEREO moved on September 26th
 - Evacuation of level C during the operation

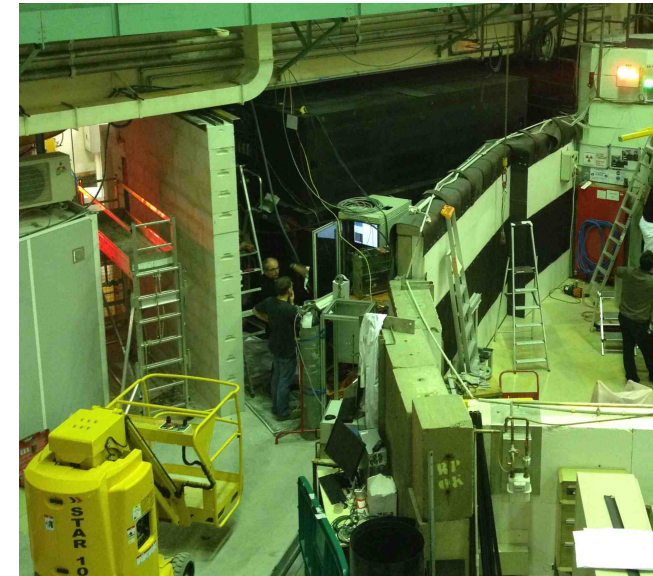
- Installation of D19 office wall (fire protection)
 - passage of cables through the wall and re-cabling
- Testing the 2 filling modules and the modified gas panel
- Flushing the detector with N2
- Commissioning the N2 sky regulation
- Delivery of 26 barrels of LS @ LPSC from MPIK
- Delivery of retention trays @ ILL from Saclay
- Definition of the filling procedure
